Some C6 Vette owners may have noticed their headlight lenses don't have the same clarity as they did when they were new. Many lenses have a slight cloudy fogging on the inside, (sometimes caused by blocked housing vents), some have a discoloration beginning on the outside and others have the dreaded "grazing" happening.

The second option was chosen for one member's "graze-stricken" Vette and following is a guide to how this switch over was accomplished. This article is broken down into three areas - Gaining Access to the Headlight Assembly, Removing the Headlight Assembly and Replacing the Lens.

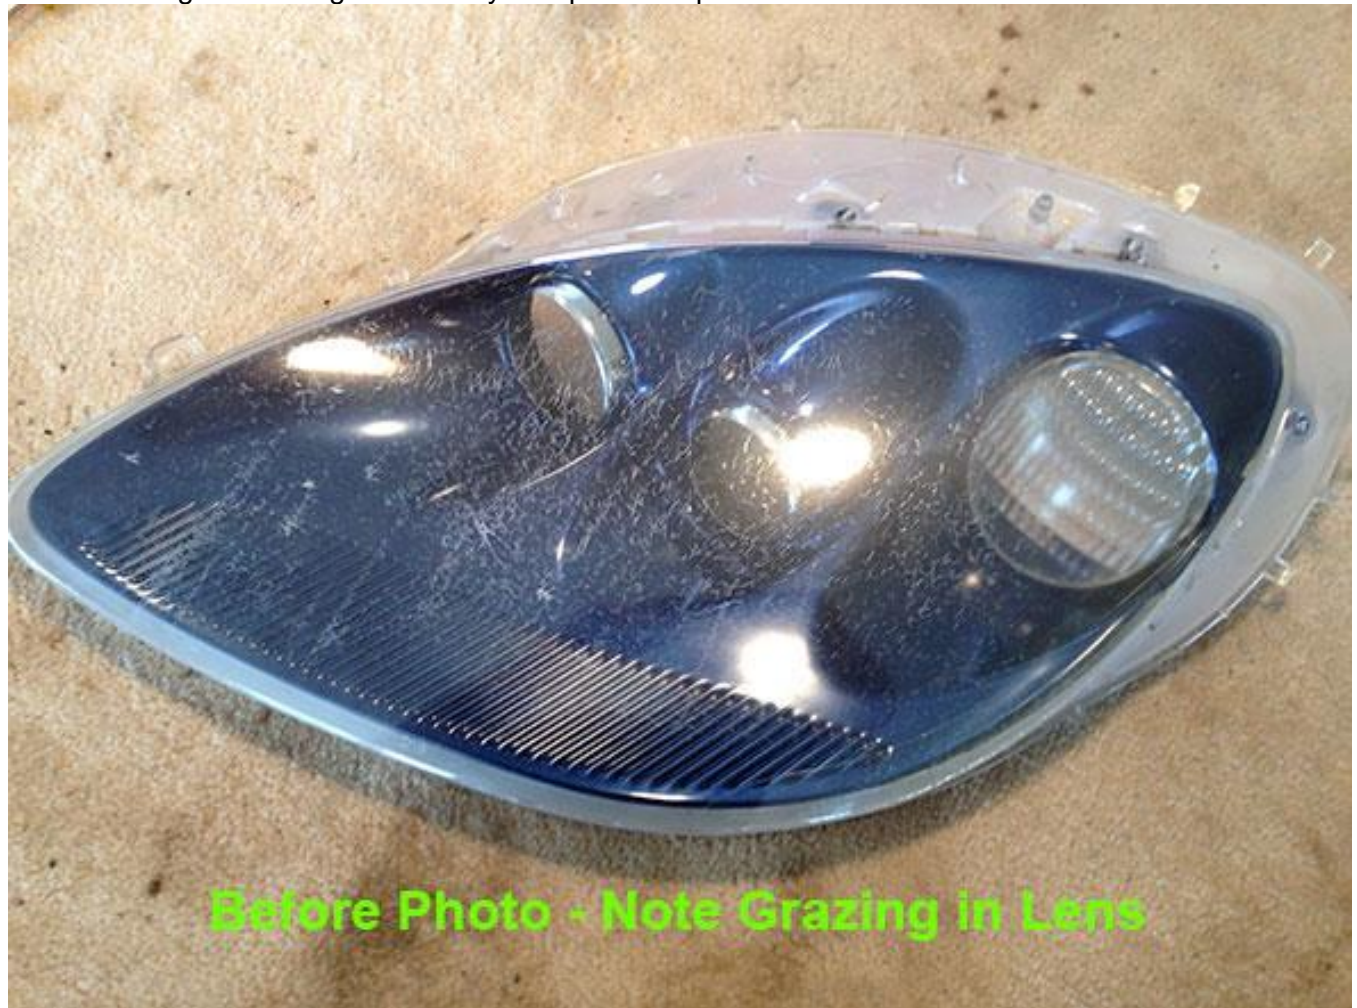
Grazing is where the lens appears to have a multitude of tiny cracks in the plastic lens. Polishing and lens restoration kits doing nothing. The lenses need to be replaced. Unfortunately this means one of two things: 1) buying a new headlight assembly from GM for around \$1600 a piece or, 2) removing and disassembling the headlight assembly to replace the plastic lens.

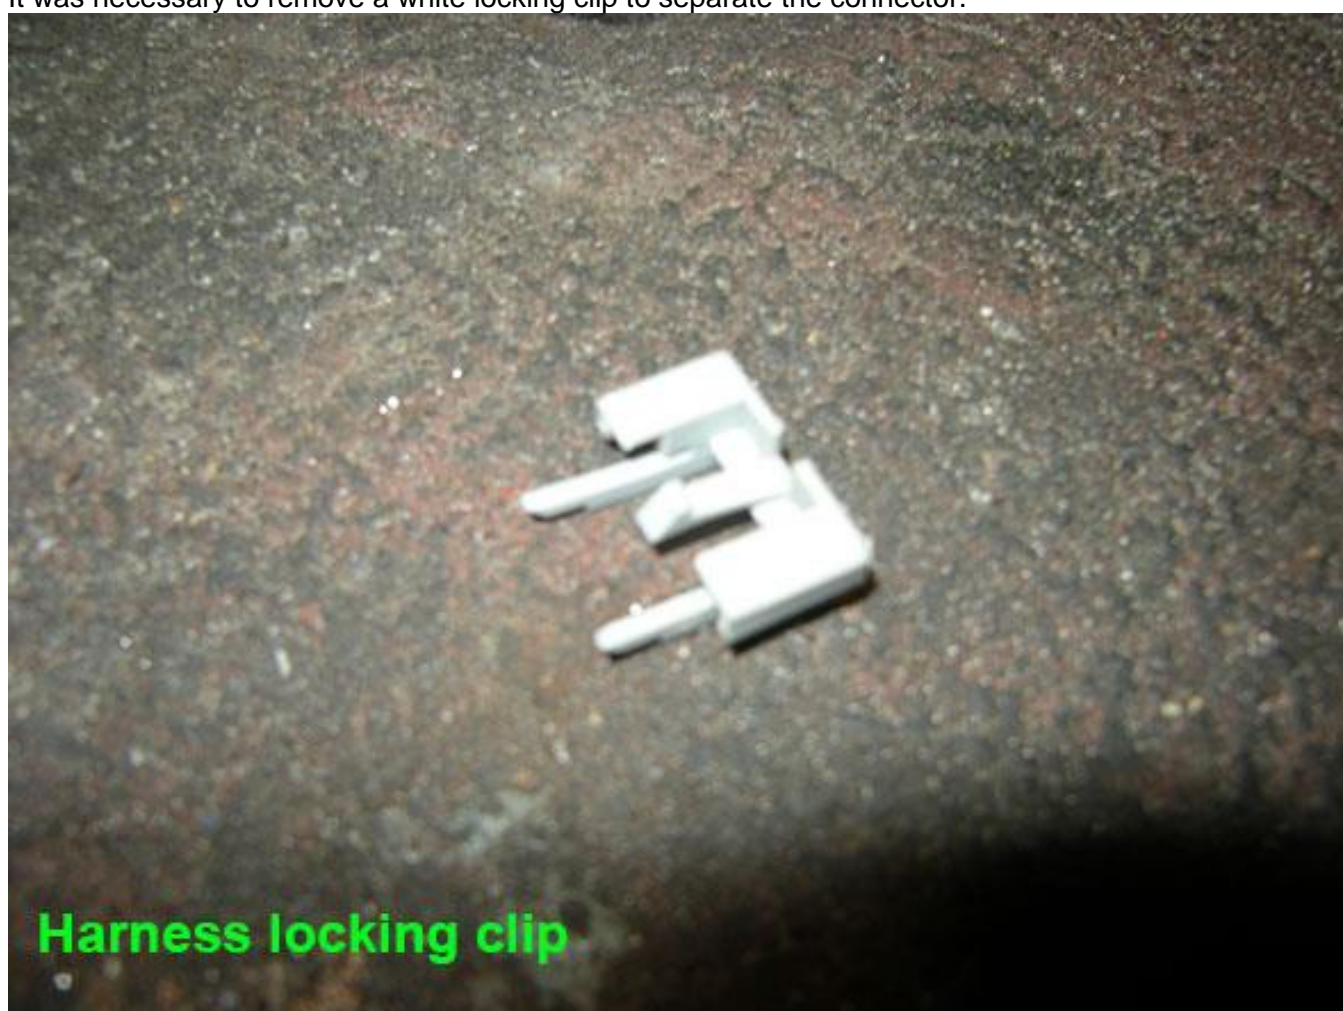
It was necessary to remove a white locking clip to separate the connector.

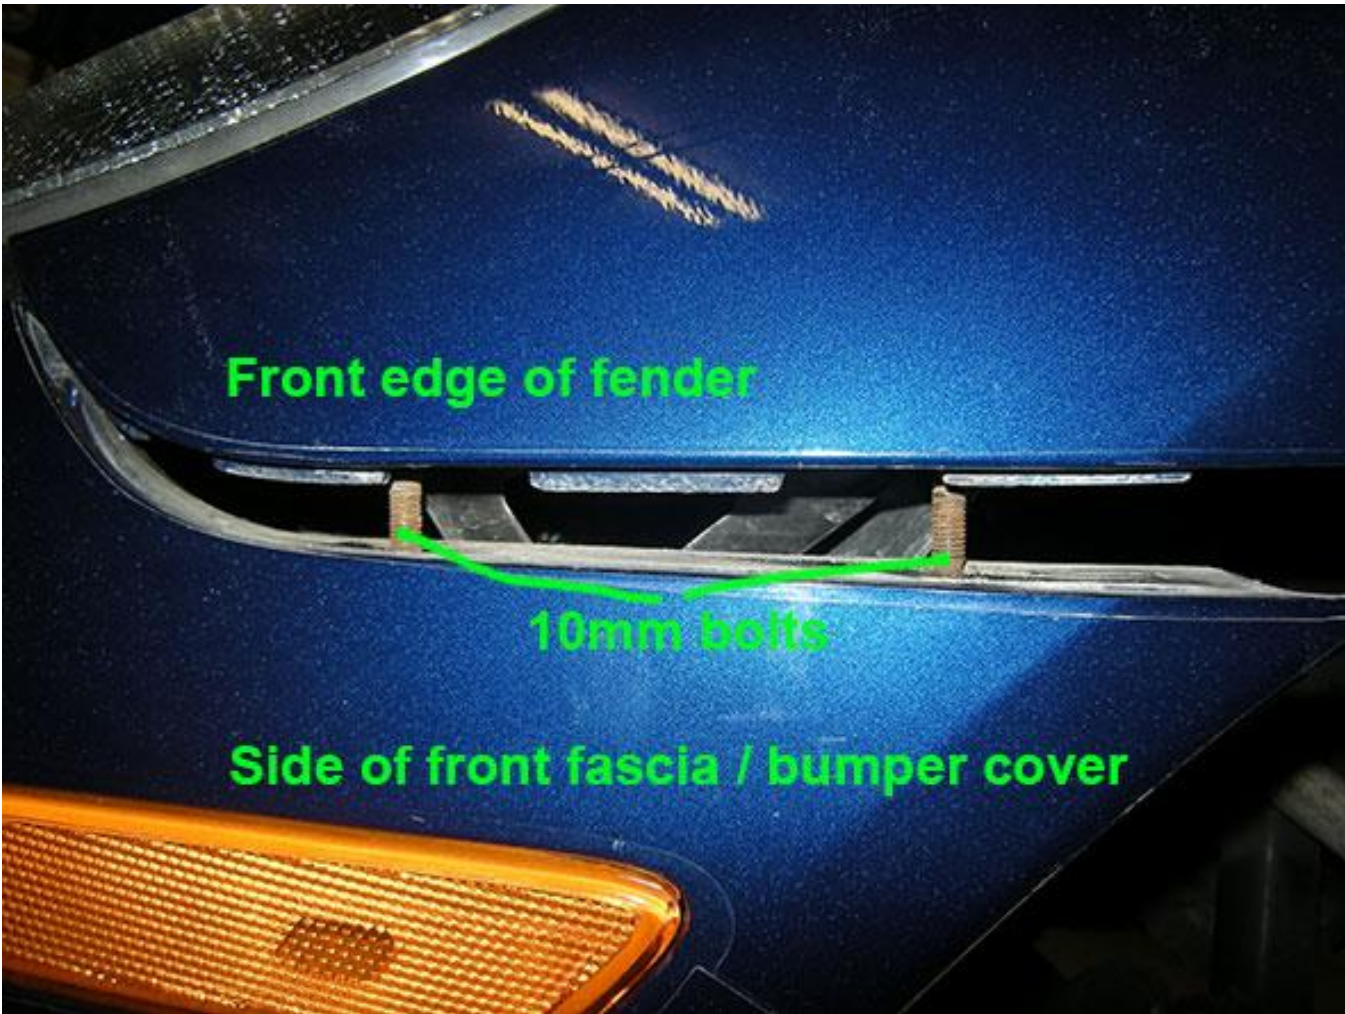
- With the liners removed and the light assemblies disconnected, the front fascia can be disconnected where it is joined to the front fenders by removing the 10mm nuts on each side. (# 10 in diagram above and photo directly above)

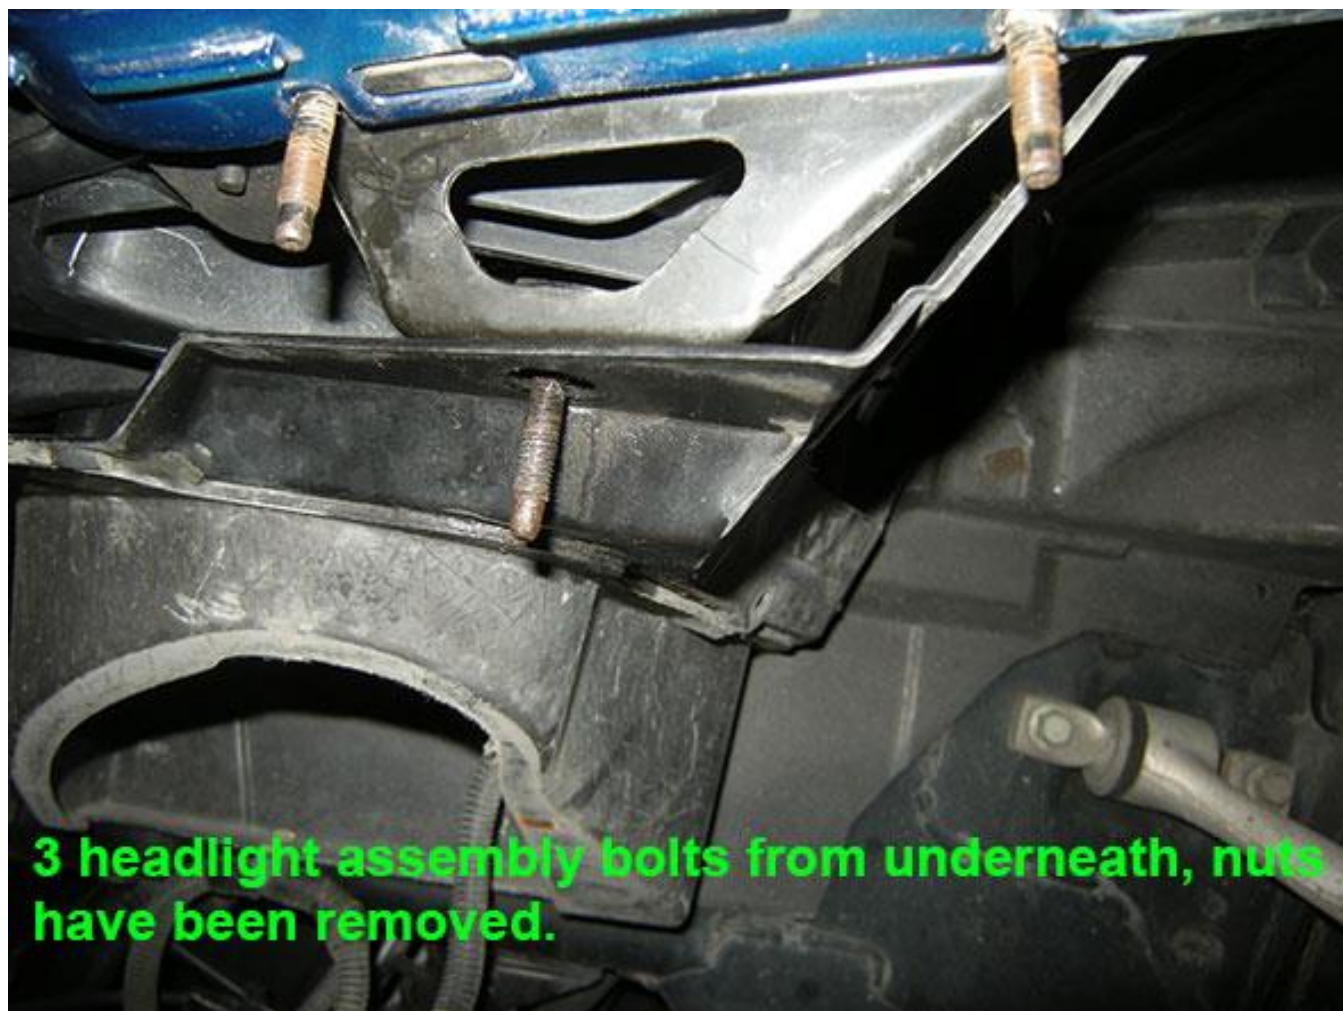
3 headlight assembly bolts from underneath, nuts have been removed.

Three nuts with washers that connect the assembly to the sub-frame are removed from the underside. With these nuts removed, the headlight assembly can be persuaded out of it's position and taken from the car.

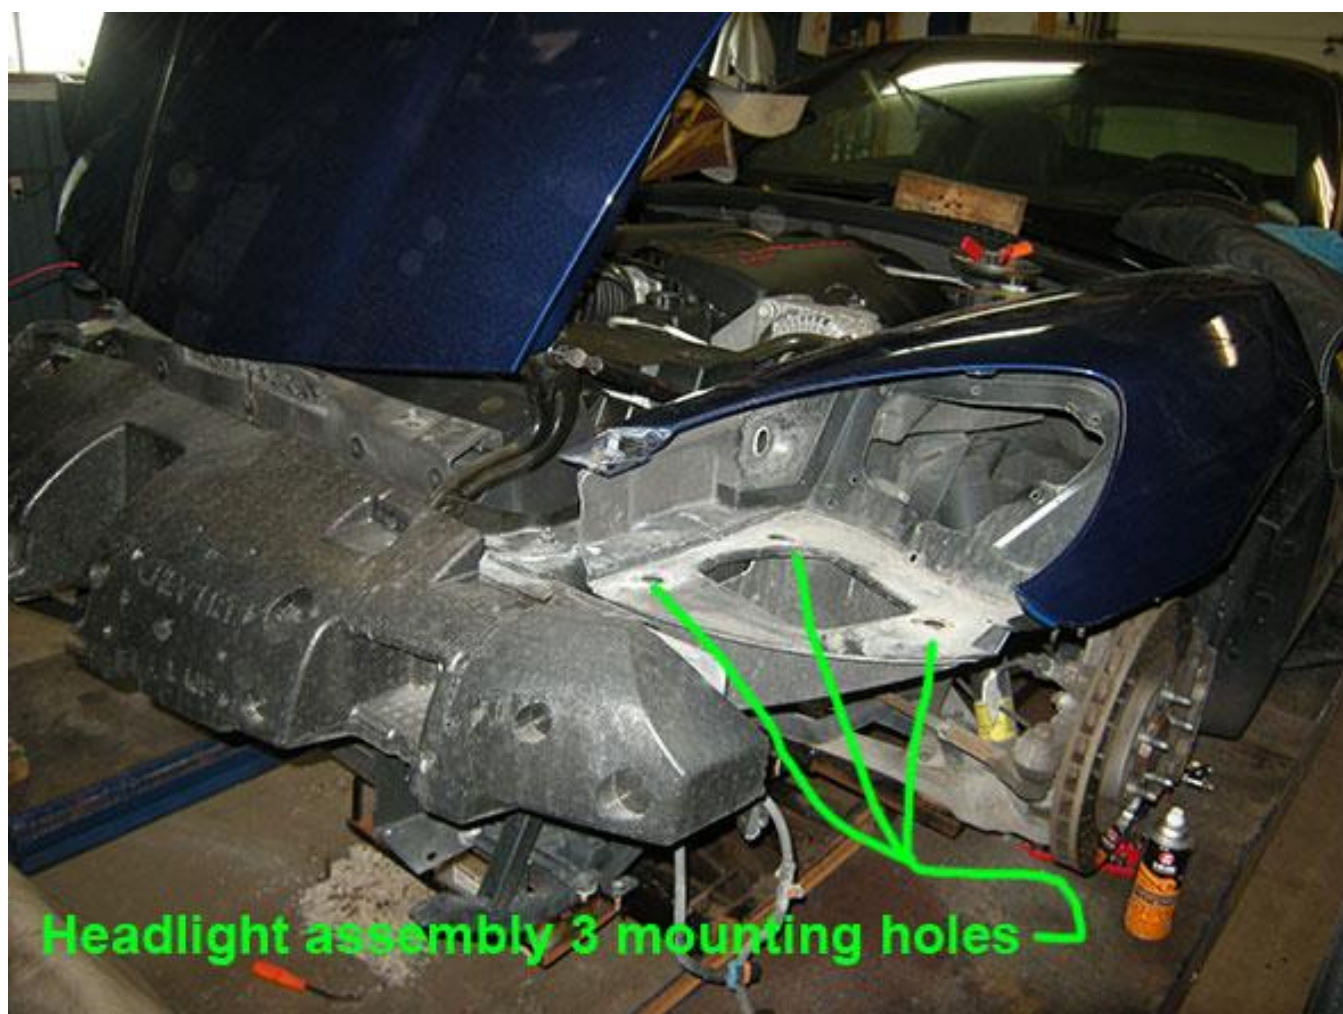
Headlight assembly 3 mounting holes

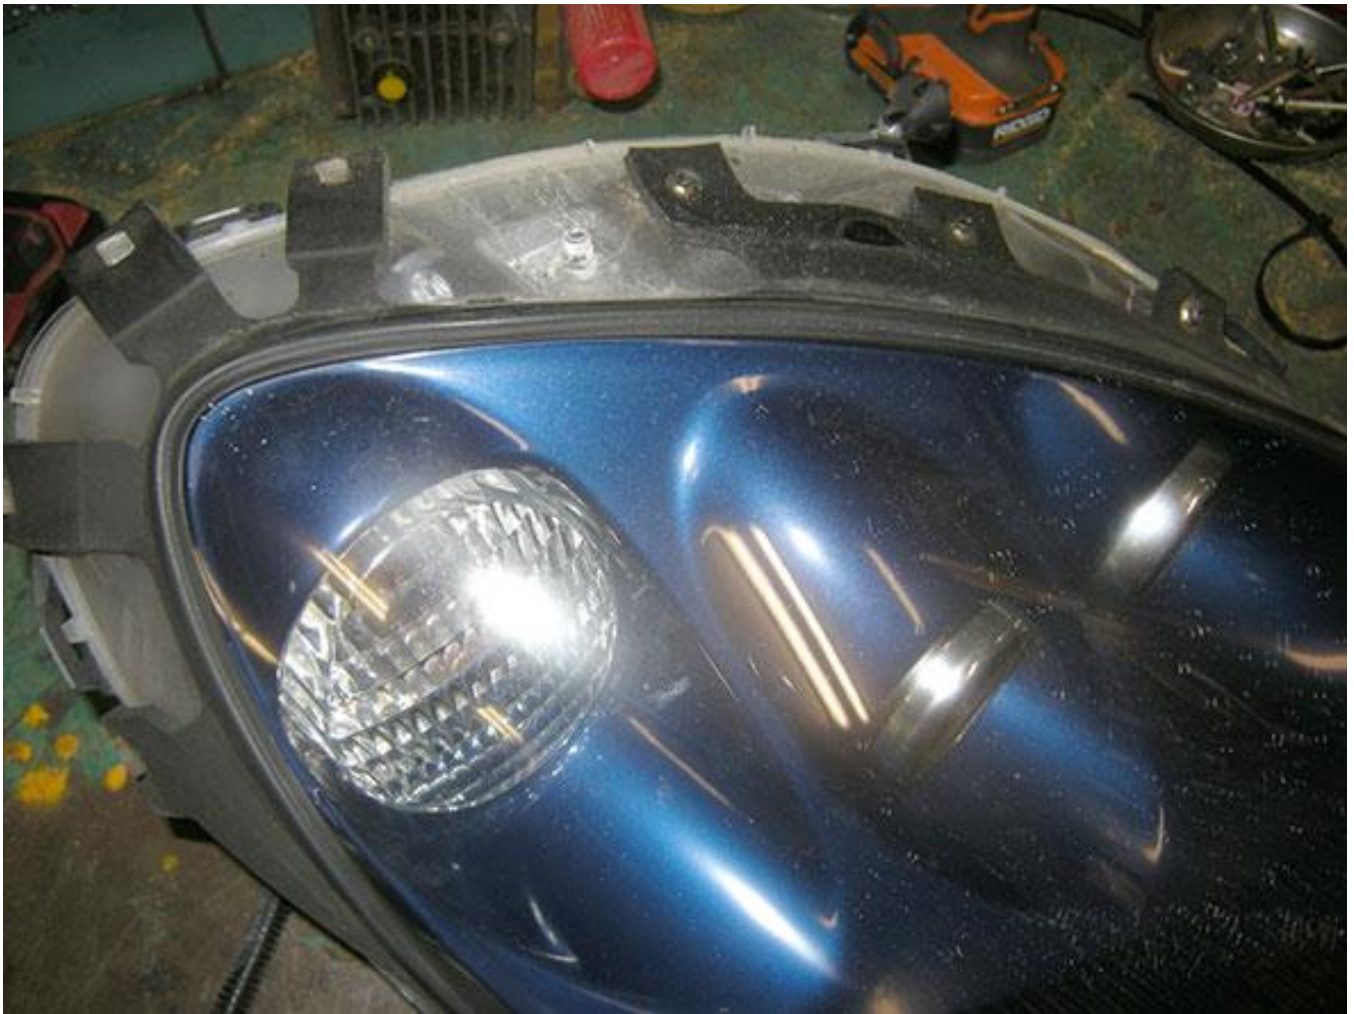
Headlight assembly removed.

Headlight assembly removed from the car - note the body gasket that keeps the lens away from the body, when the headlight is installed in the car. This is removed at this stage of the game.

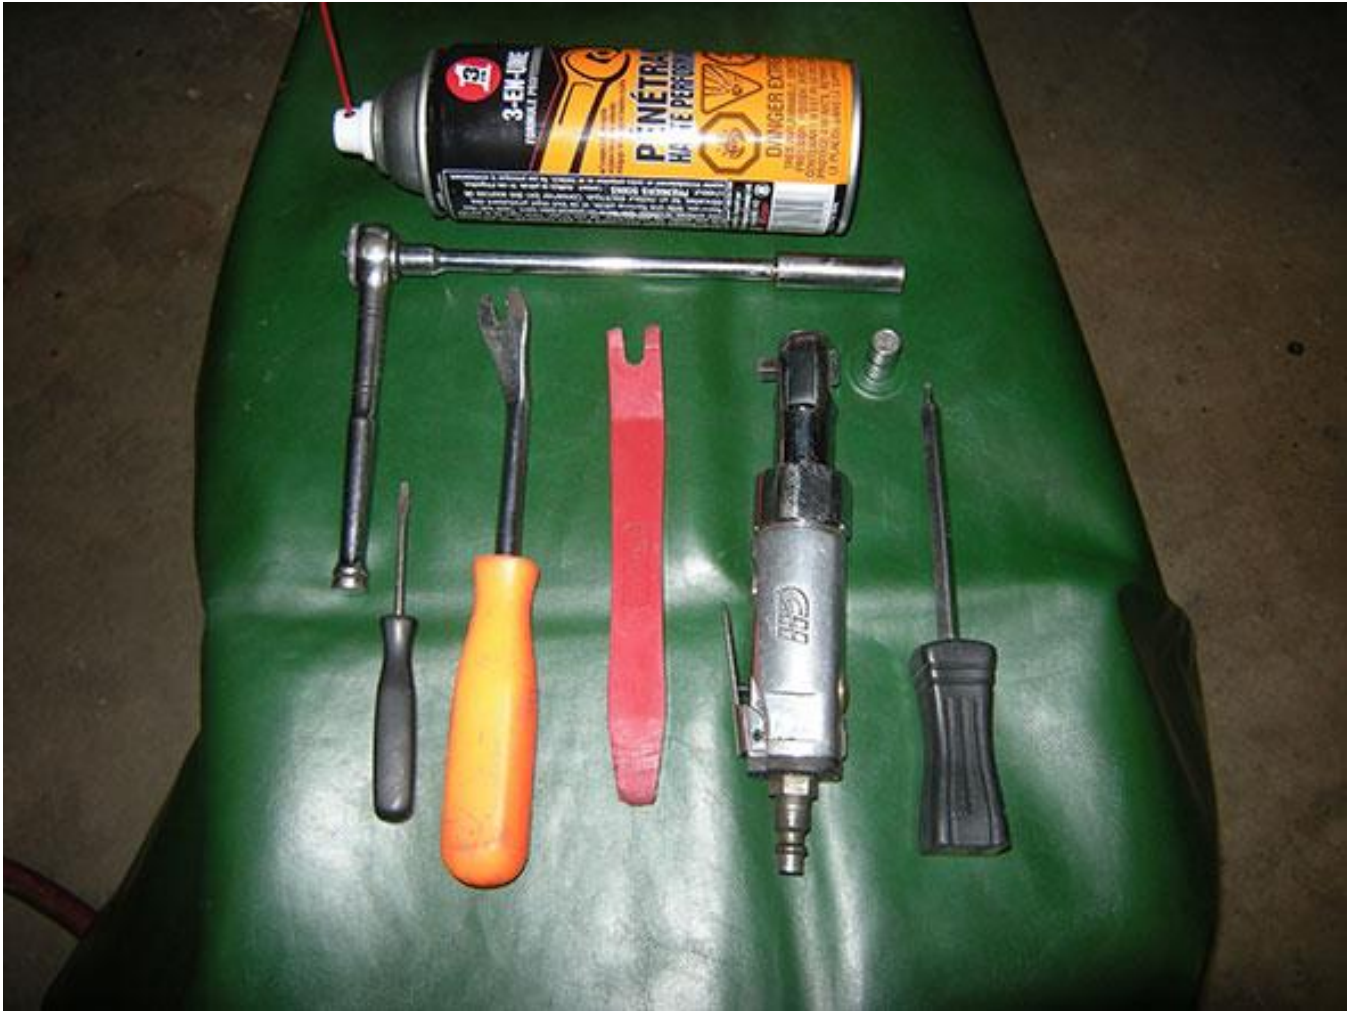
Tools used removing the bumper fascia and head light assembly.

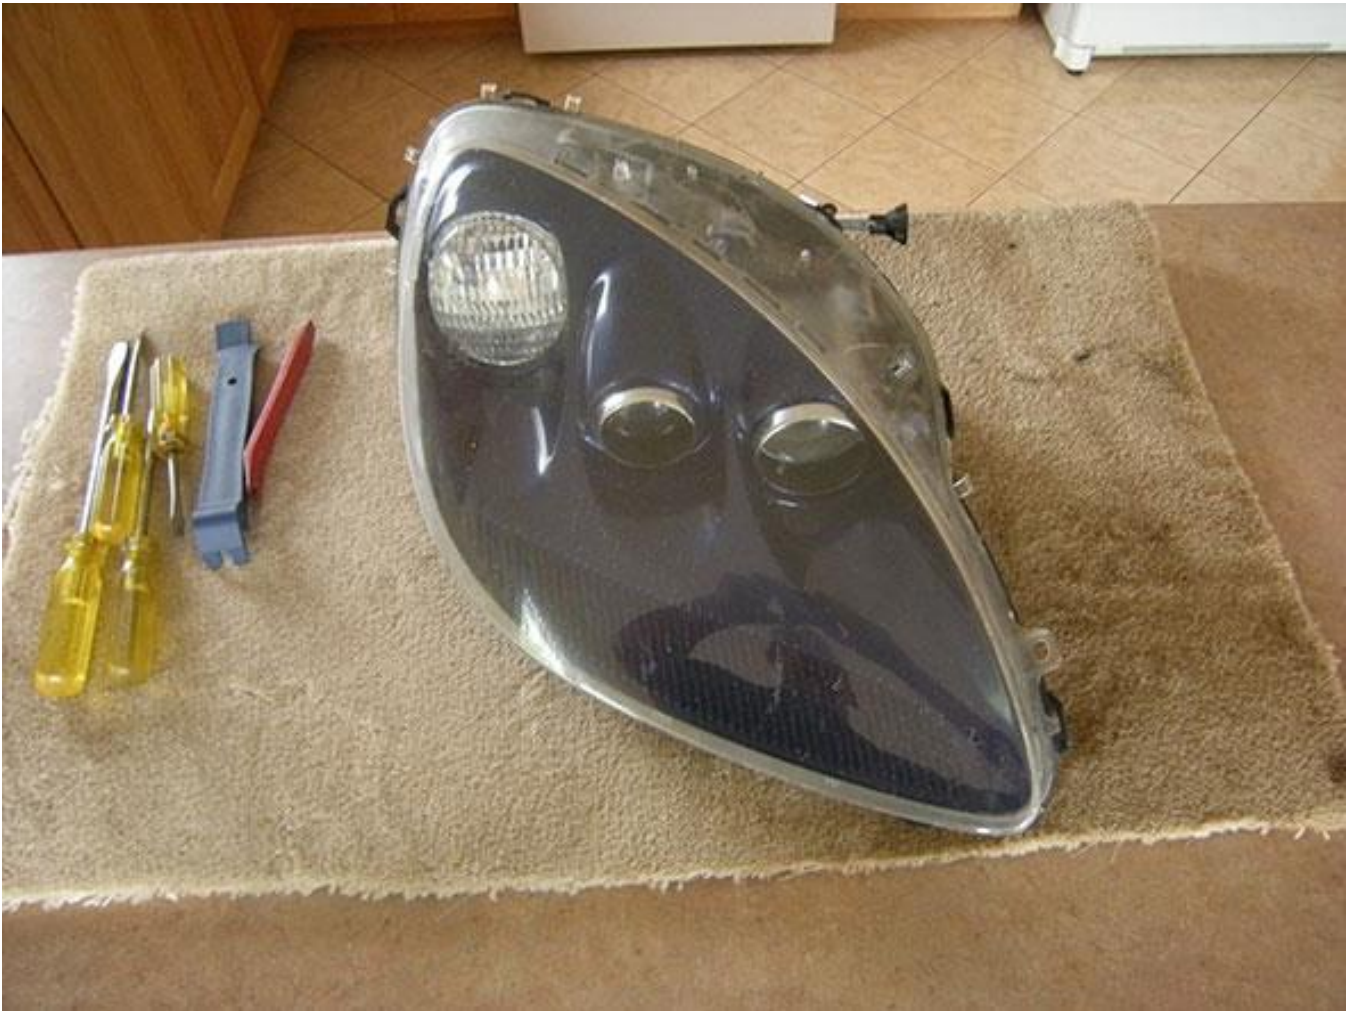
Headlight assembly with old lens and tools used to remove lens from assembly.

With the assembly removed, the next challenge was separating the old lens from the main body of the headlight assembly. It was glued in place at the factory and in order to remove it, it was necessary to heat and soften the factory glue to pry the old lens out.

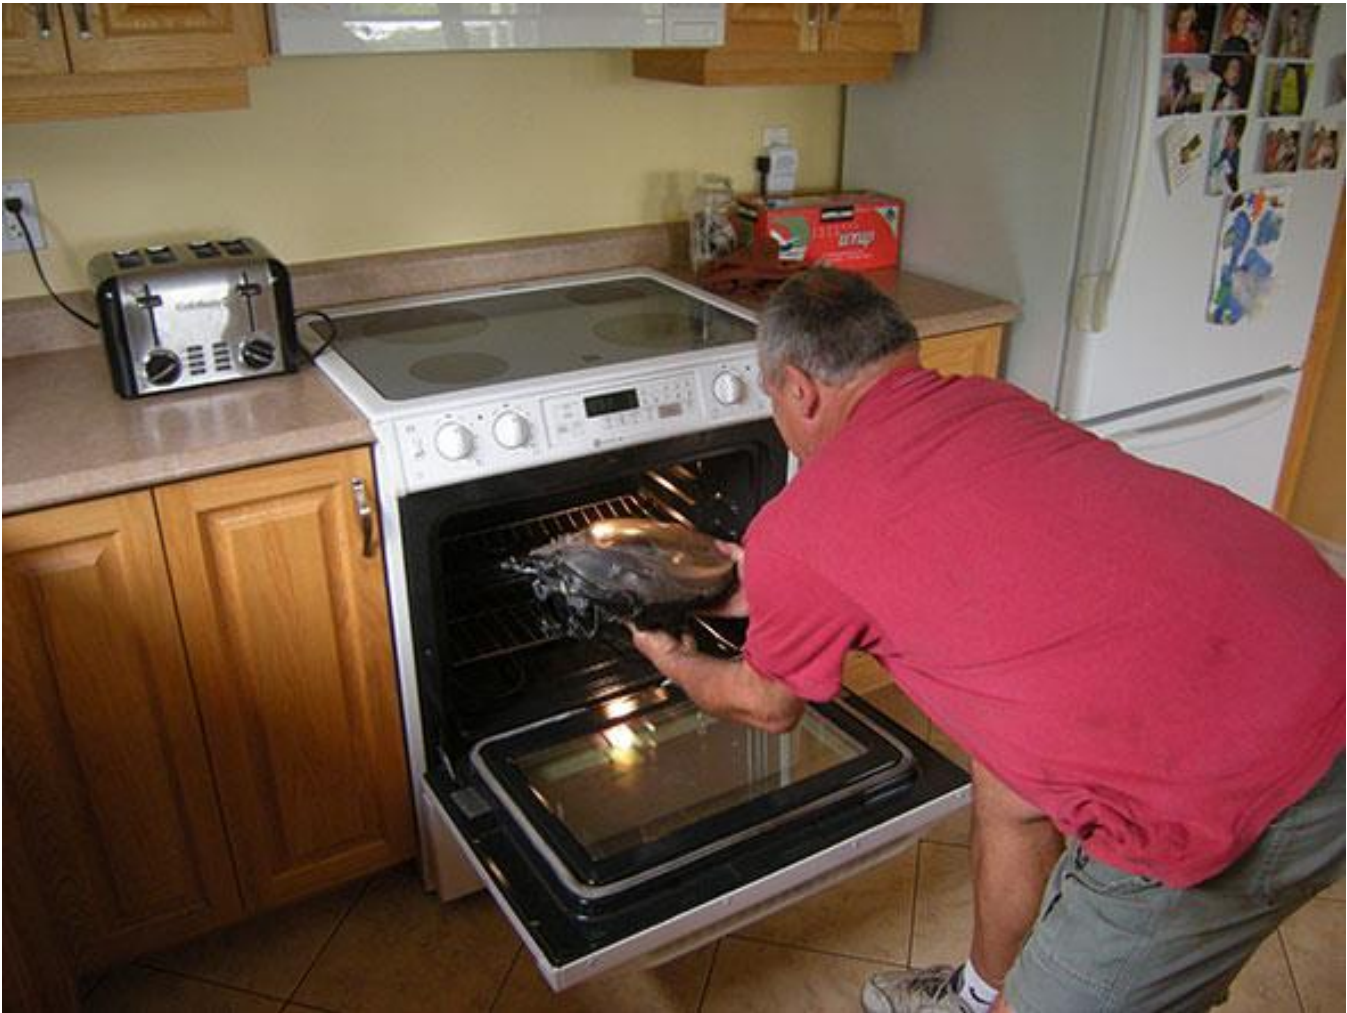
That ain't no turkey that's going in the oven. (An oven recently cleaned by Kim!) Preheat the oven to 350 degrees and when it reaches that temperature, turn it off and stick the headlight assembly in for about 20 minutes. When it comes out, wear gloves to handle it - it will be hot!

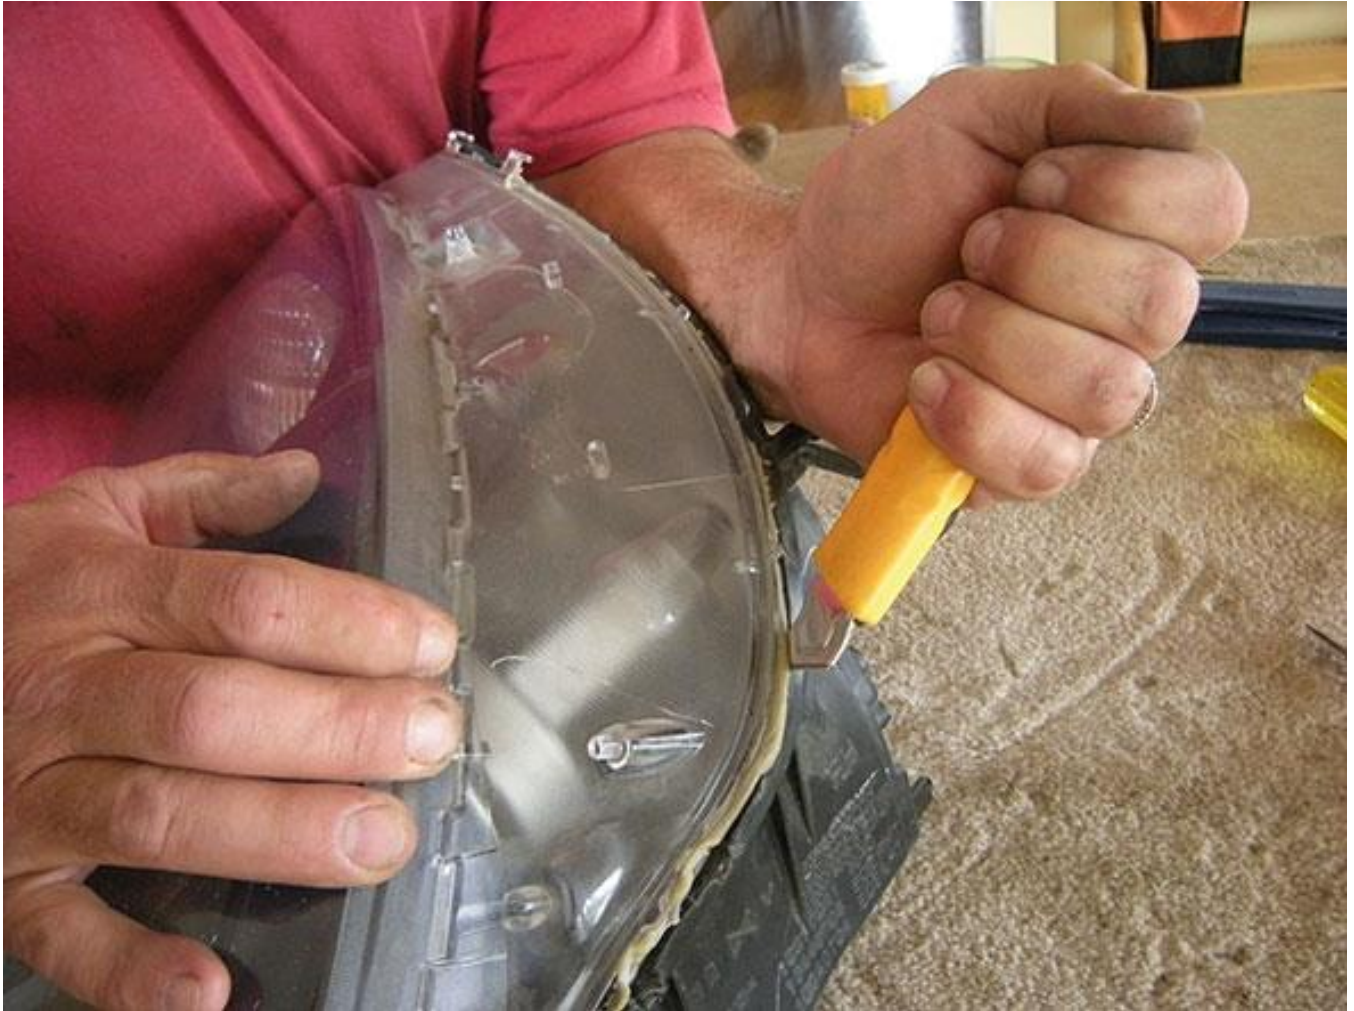
I used two flat blade screwdrivers and worked them into the seam between the clear lens and body and started prying the two apart. When the gap is large enough, I put my fingers in and pried the two pieces apart. I also used a sharp cutter to cut the adhesive. The rule here is "Don't Manhandle the Part!". If it doesn't come apart, then it will be necessary to reheat the assembly in the oven. I heated the assembly 3 times before I could get it apart.

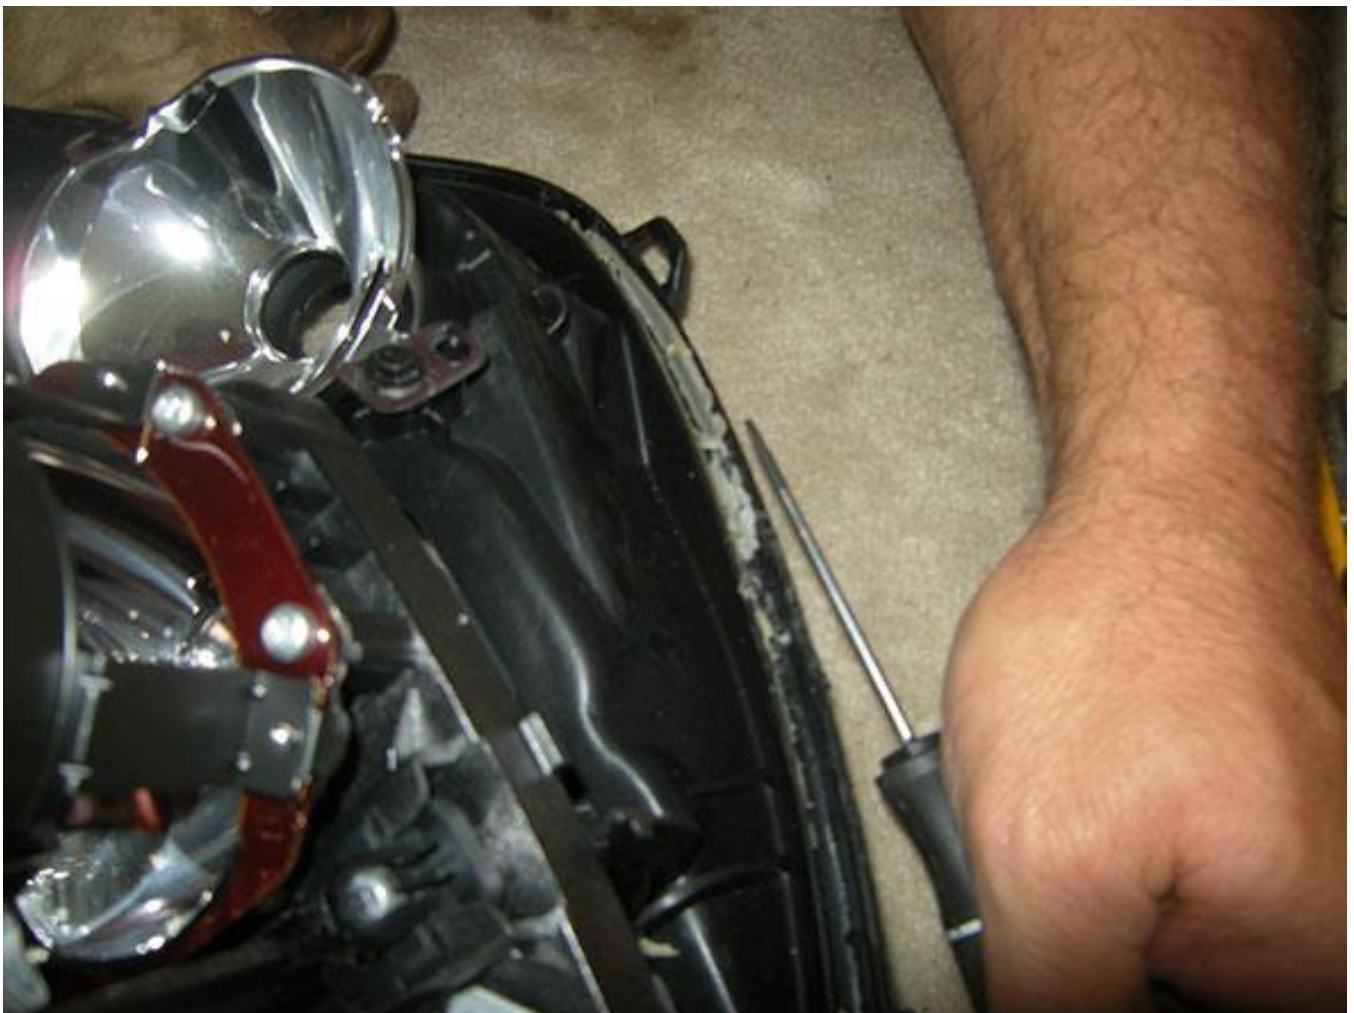
After the lens is removed, the challenge is getting the residual glue out of the groove that the lens was seated in. I used a screwdriver and pliers and worked my way around the edge of the assembly. A heat gun was used as well to soften the glue and it proved quicker than waiting for the oven heating. This is without doubt, the most difficult part of the process and resulted in some rather strong cussing!

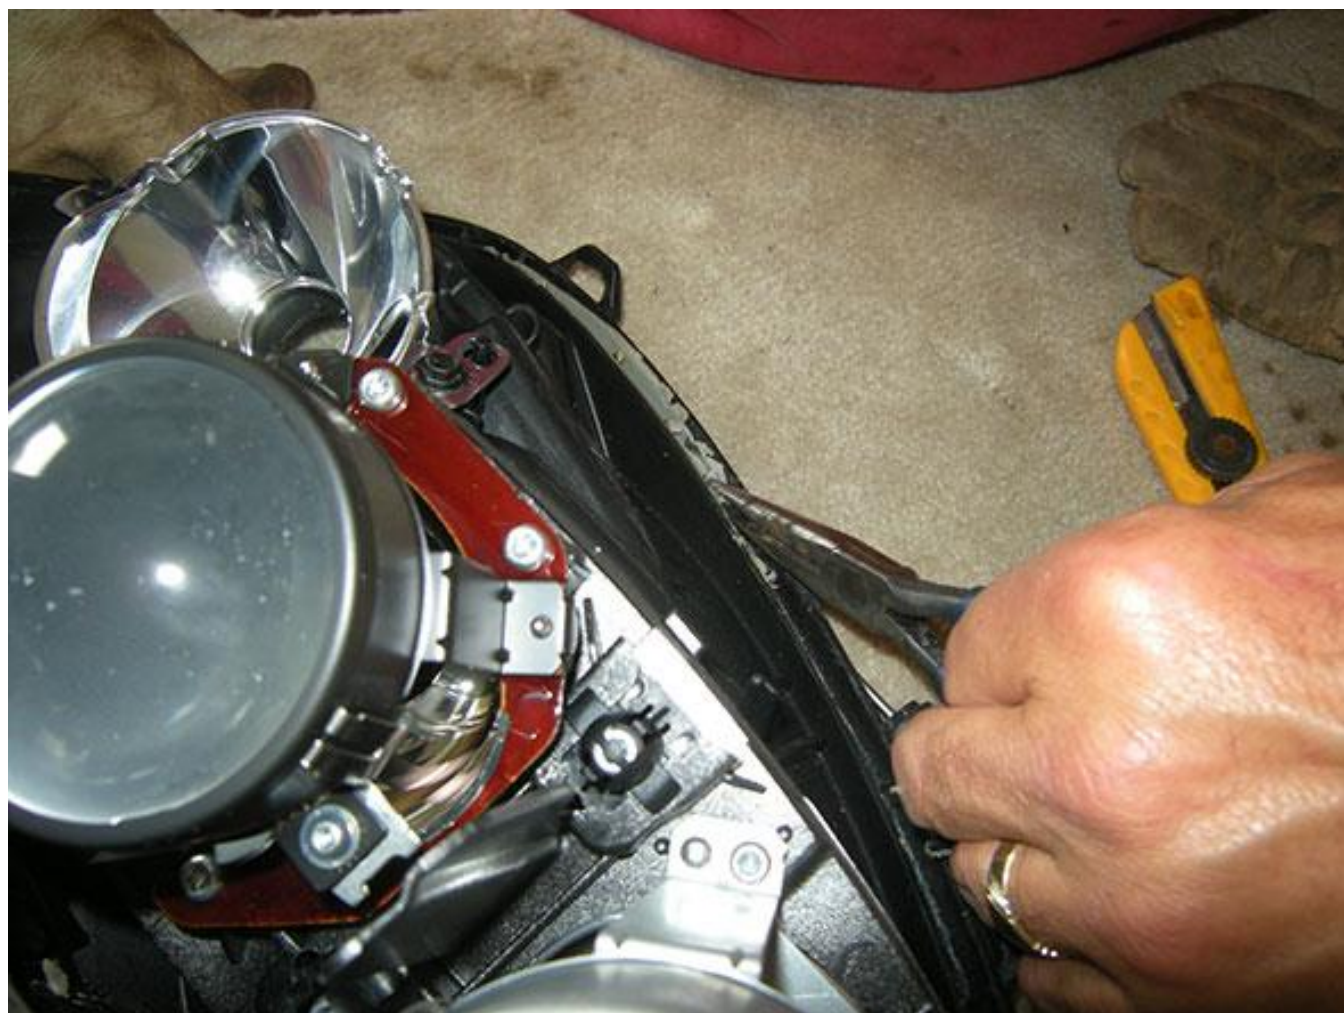
Removal of the glue was a long and tedious process - but necessary to give a clean surface for the new lens to fit into.

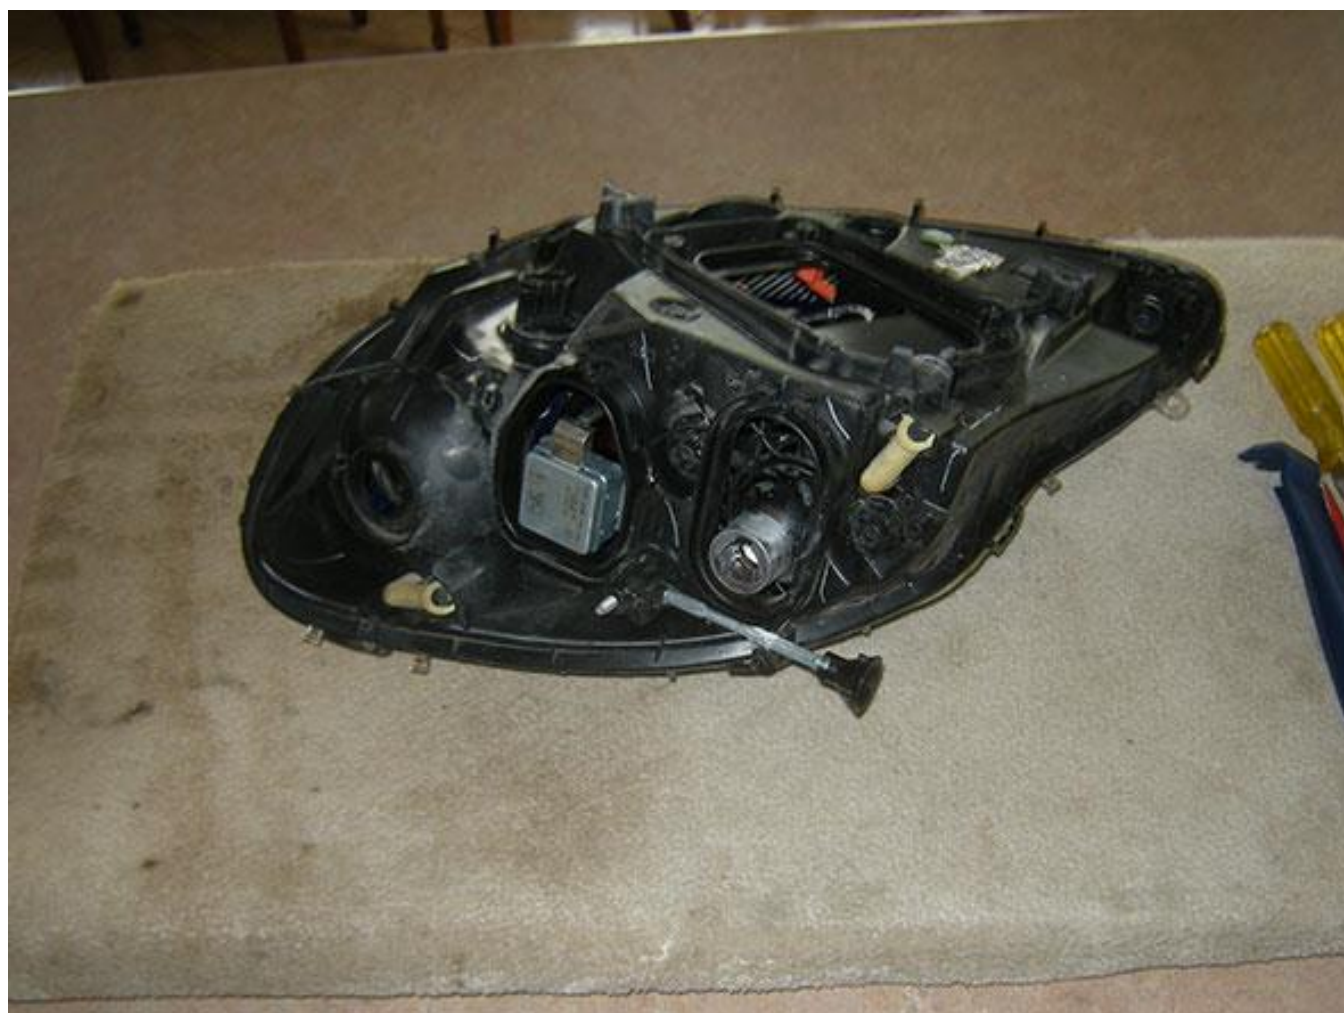
Back of assembly with clear lens removed. That odd bar sticking out with the rubber cup on the end is for adjusting the aim of the headlight.

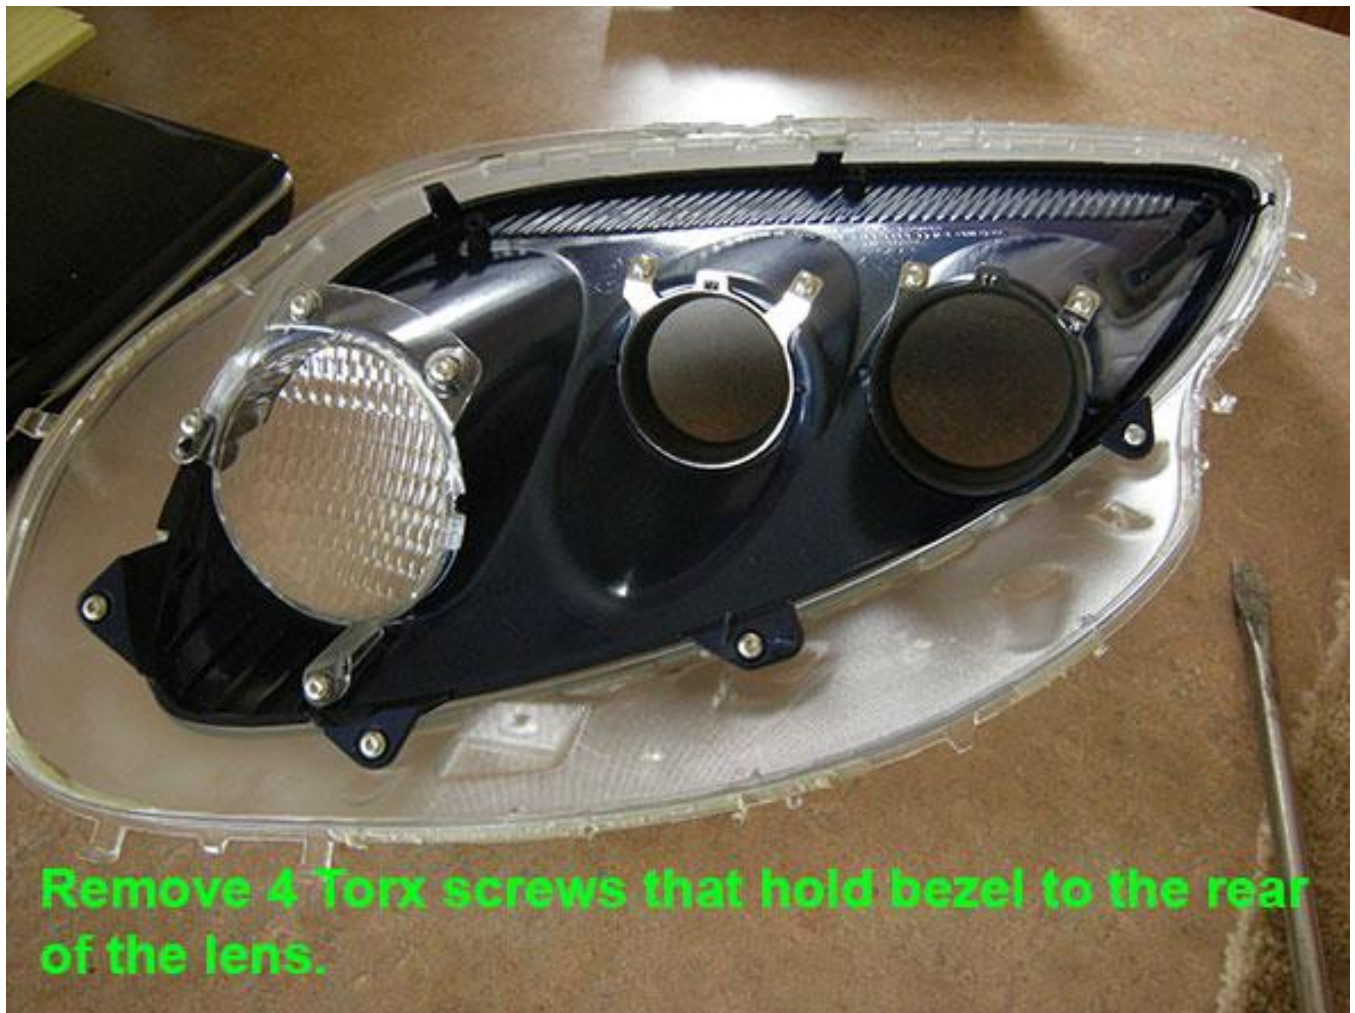
Remove 4 Torx screws that hold bezel to the rear of the lens.

The last step of disassembly is removing the bezel from the lens. The old grazed lens now belongs in the trash. Thank goodness!

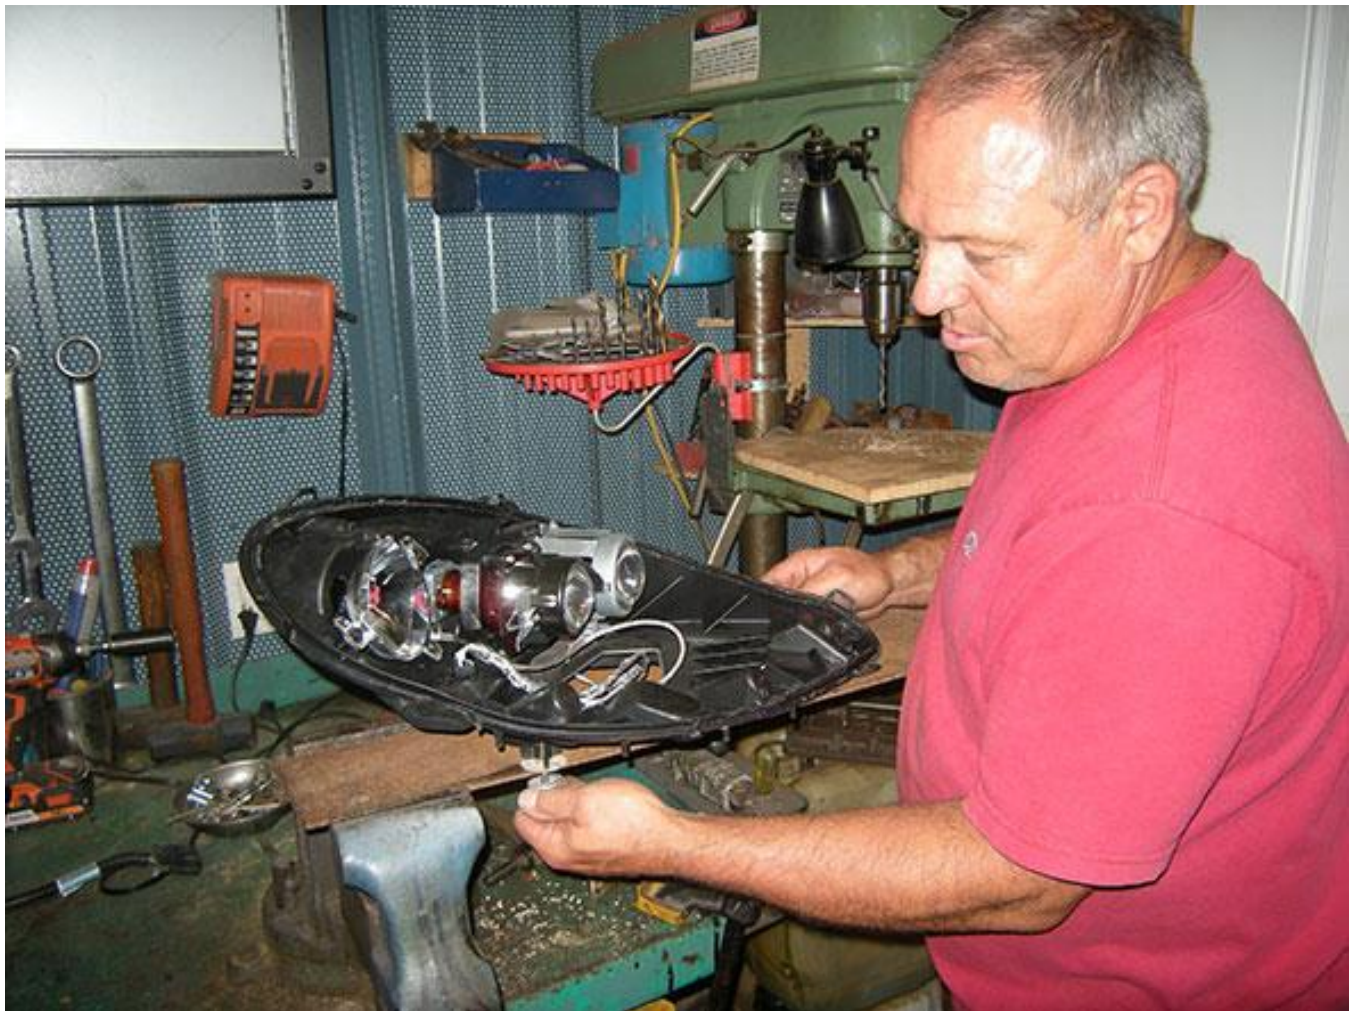
I made a temporary jig to mount the headlight assembly onto so it would be easier to work with.

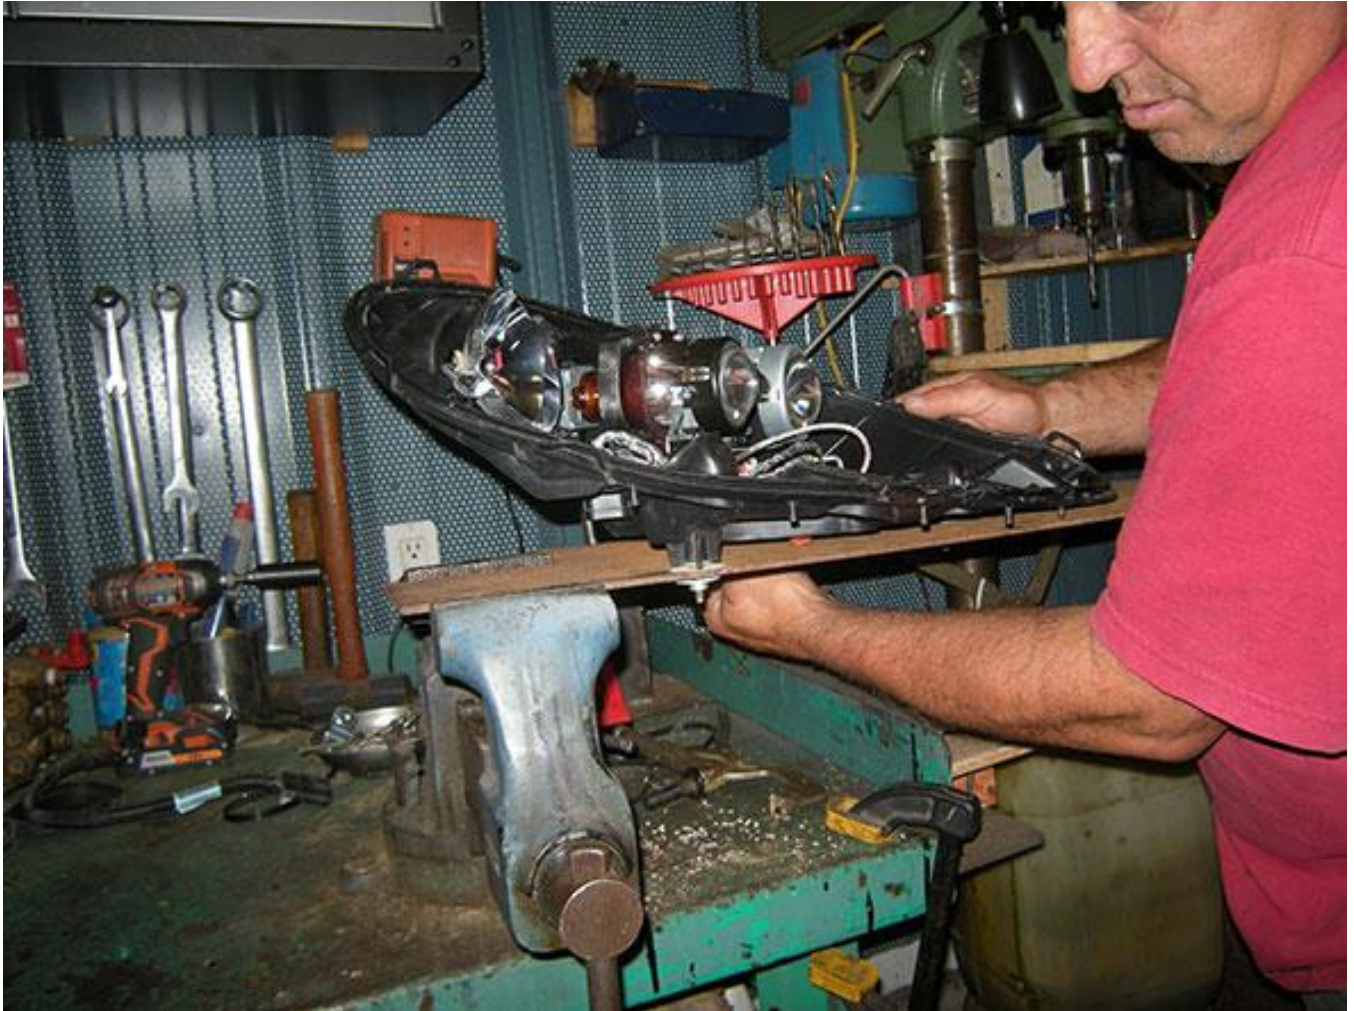
The light assembly's three mounting bolts were attached to the jig. The light projectors were cleaned and the entire inside of the housing was blown free of dust and debris with an air hose.
