Some C6 Vette owners may have noticed their headlight lenses don't have the same clarity as they did when they were new. Many lenses have a slight cloudy fogging on the inside, (sometimes caused by blocked housing vents), some have a discoloration beginning on the outside and others have the dreaded "grazing" happening.

The second option was chosen for one member's "graze-stricken" Vette and following is a guide to how this switch over was accomplished. This article is broken down into three areas - Gaining Access to the Headlight Assembly, Removing the Headlight Assembly and Replacing the Lens.

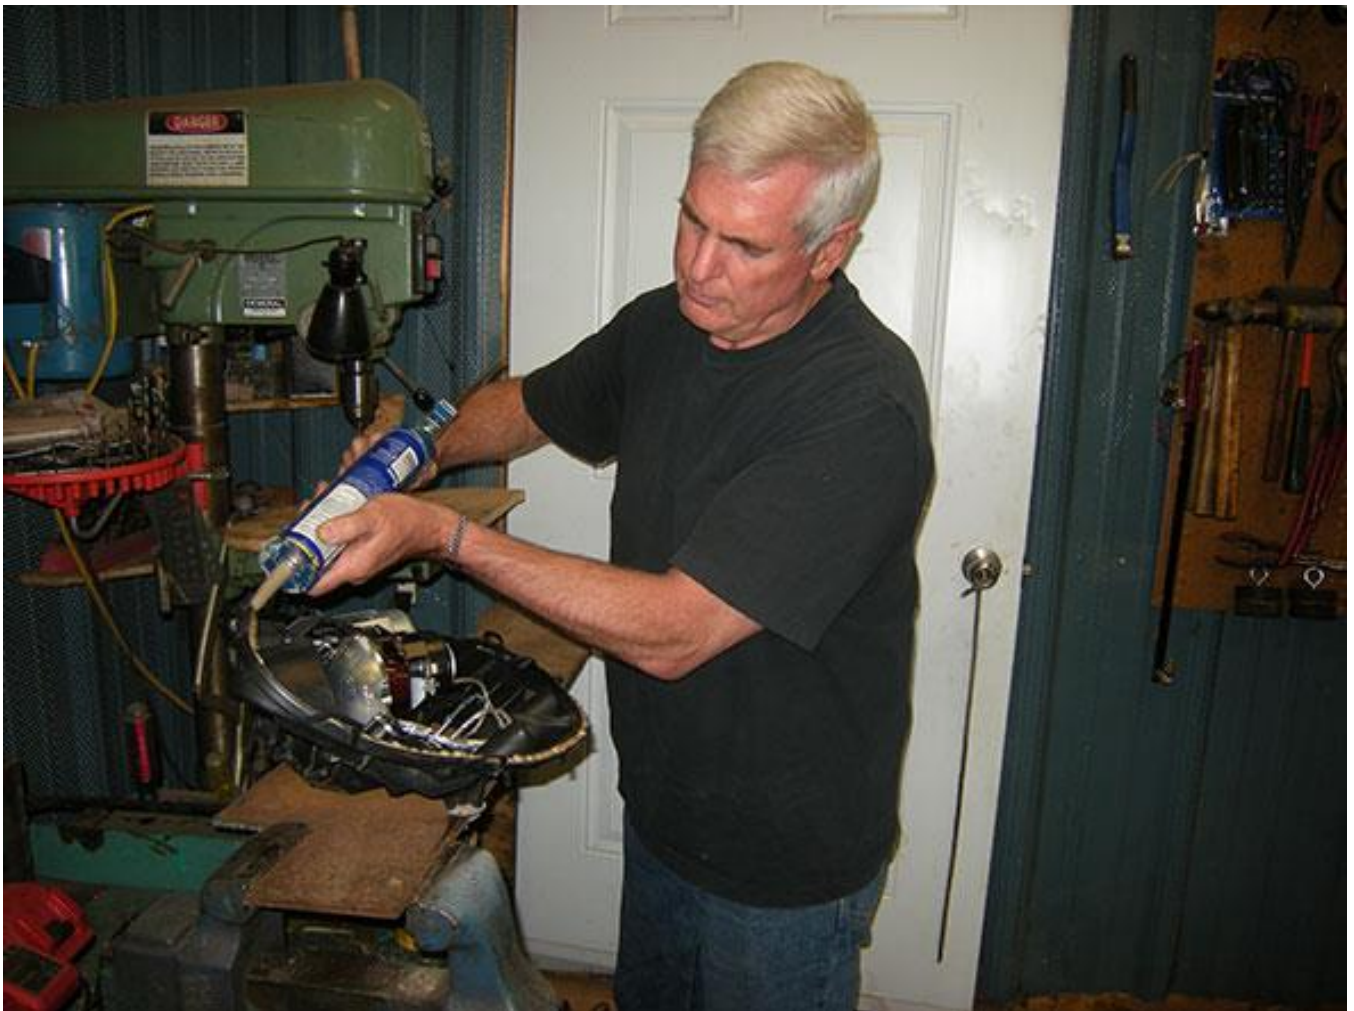
My "young" apprentice was responsible for filling the gap with glue again. We used Loctite PL polyurethane adhesive. LePage's construction glue would also work. One tube is more than enough for two lenses.

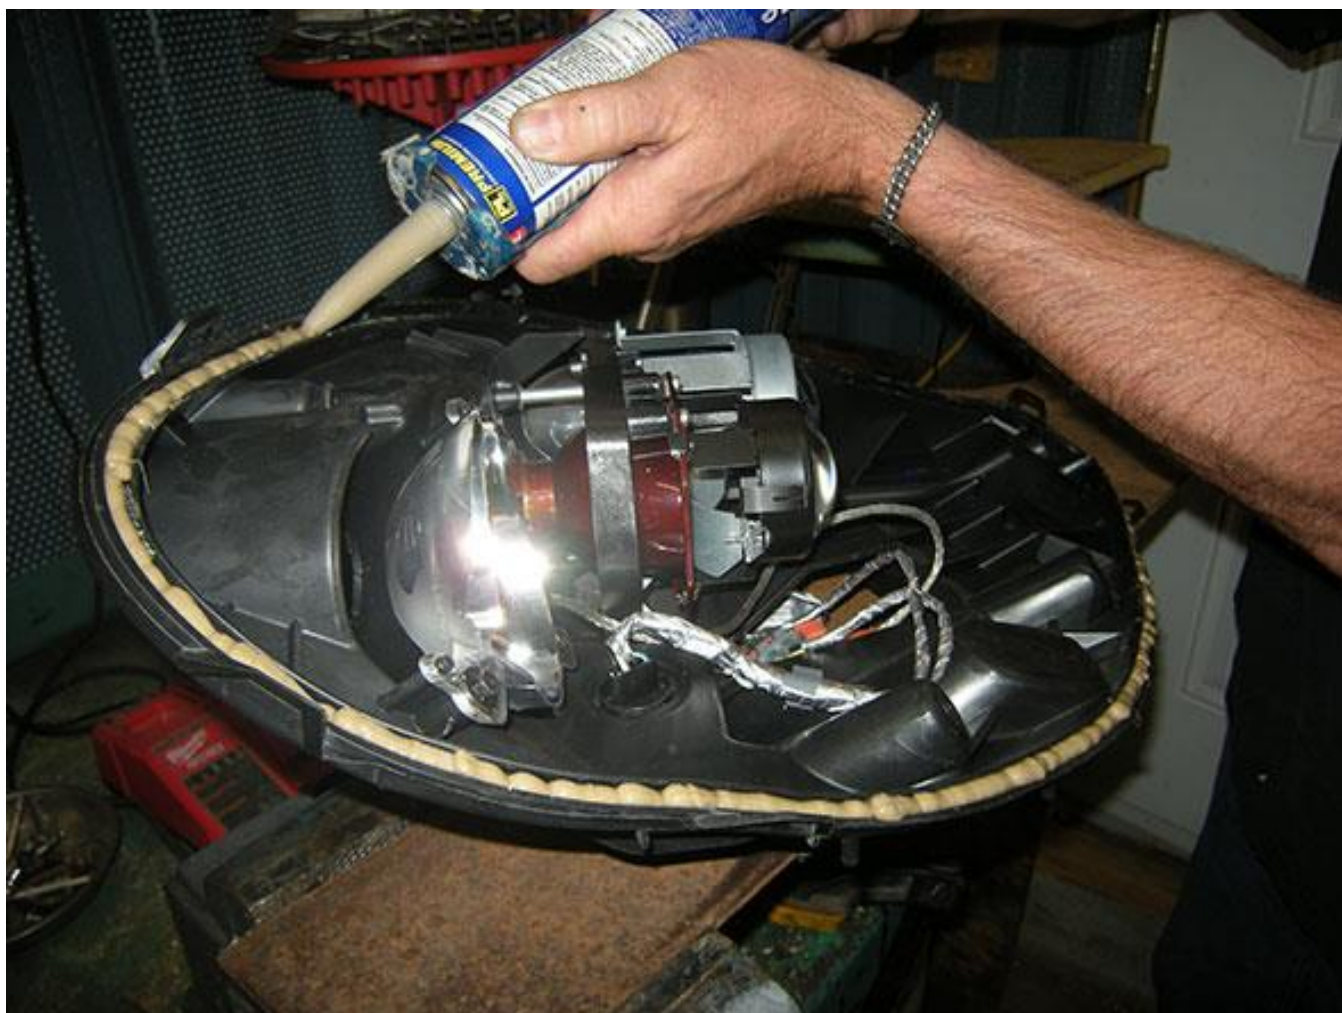
The goal was to get an even, continuous bead of the bonding glue all the way around the groove in the housing.

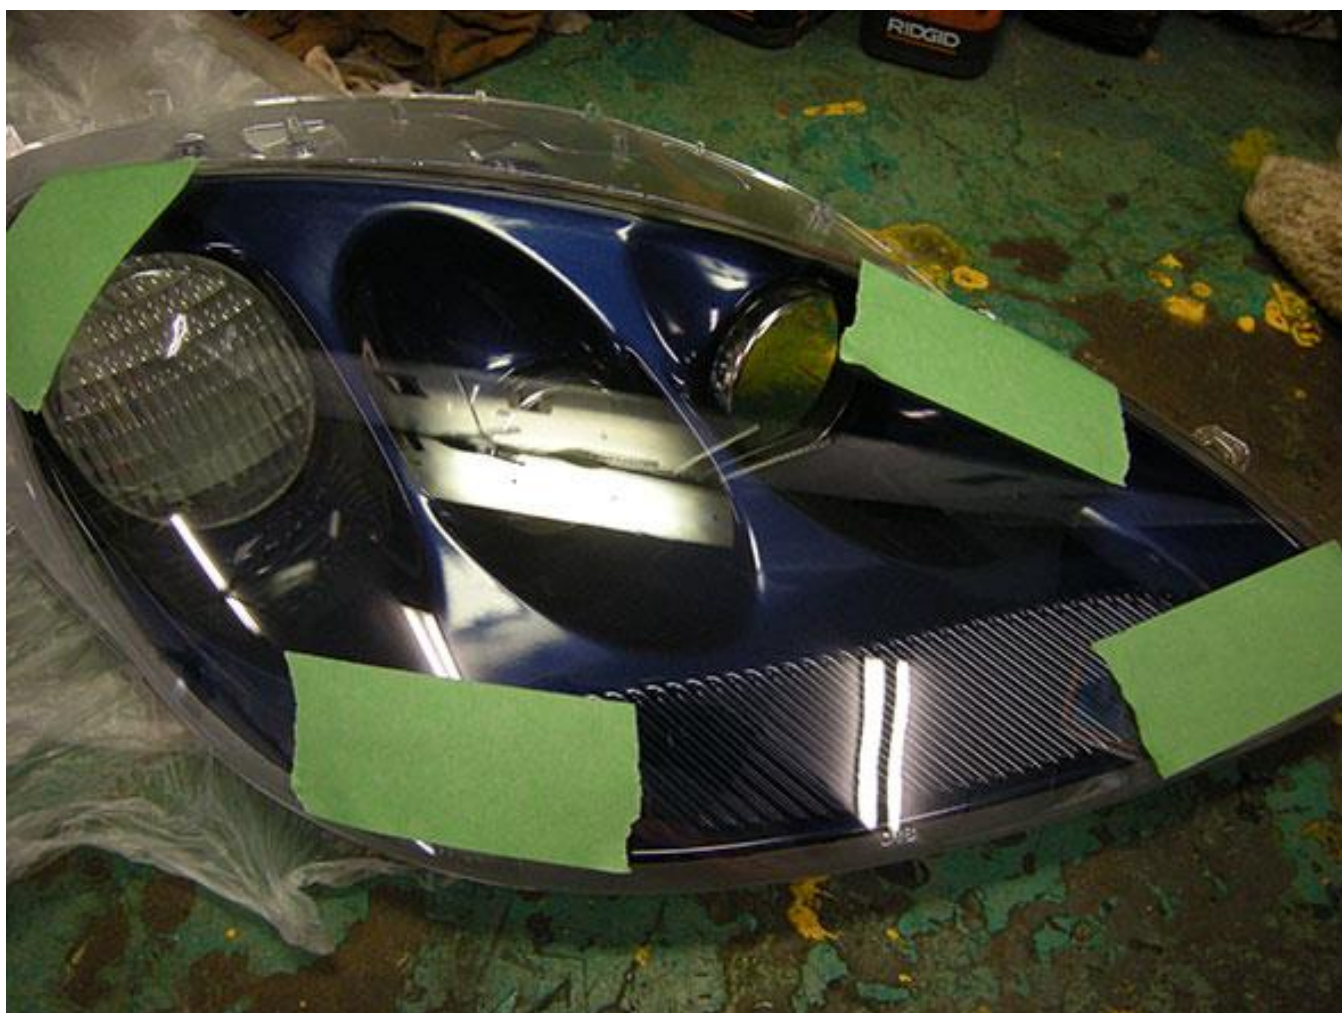
The new bezel is installed in the lens and protective tape is placed on the lens in preparation for clamping. With the glue in the housing, the new lens was put in place.

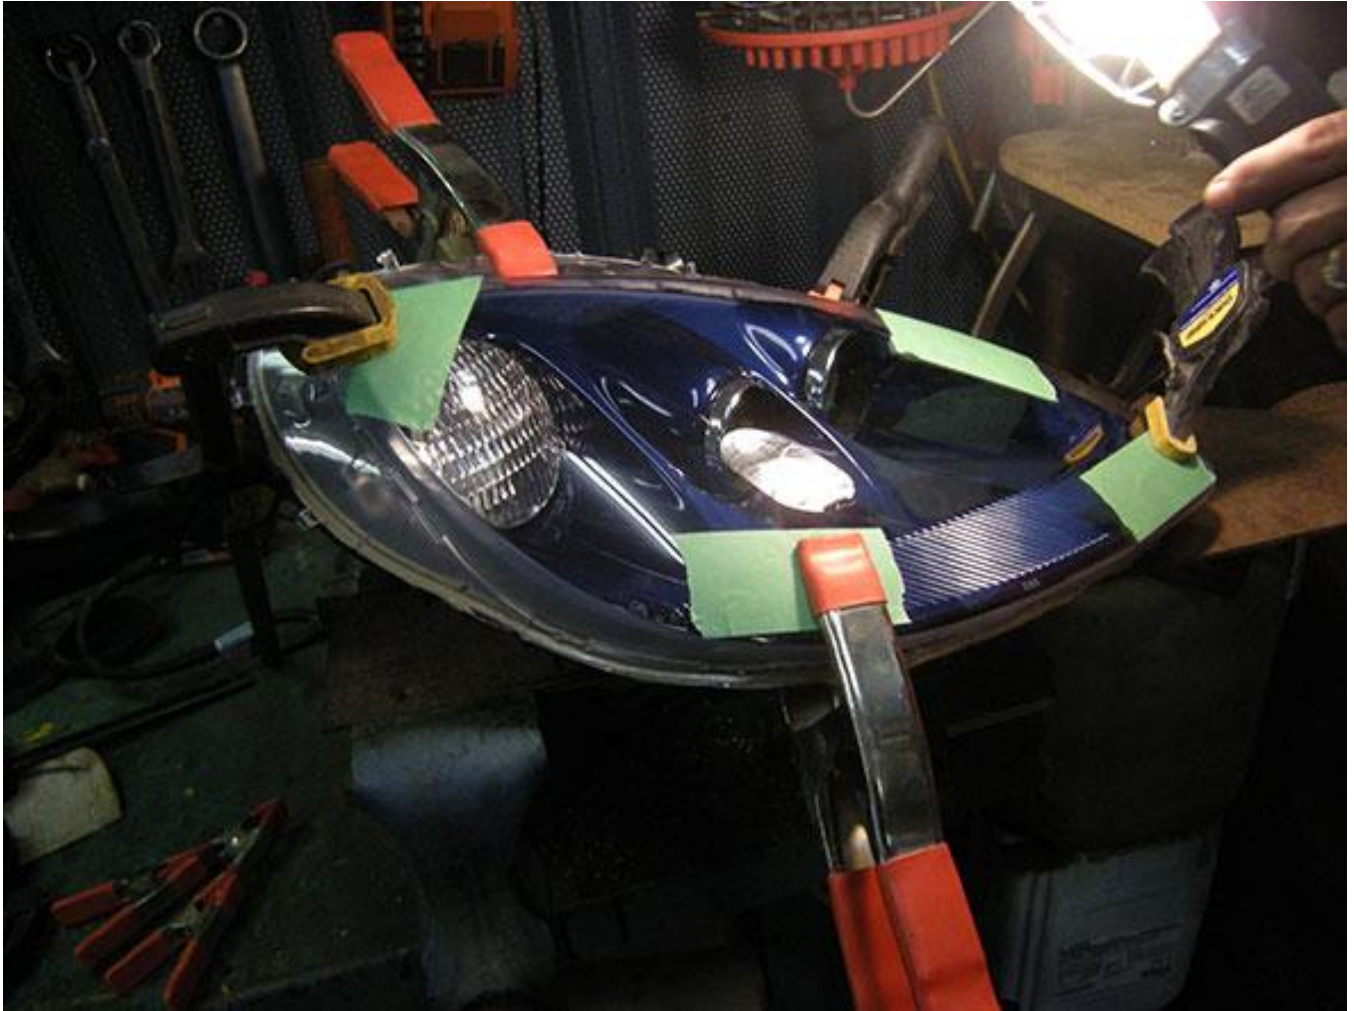
Clamps were placed around the lens to hold it while the glue set.

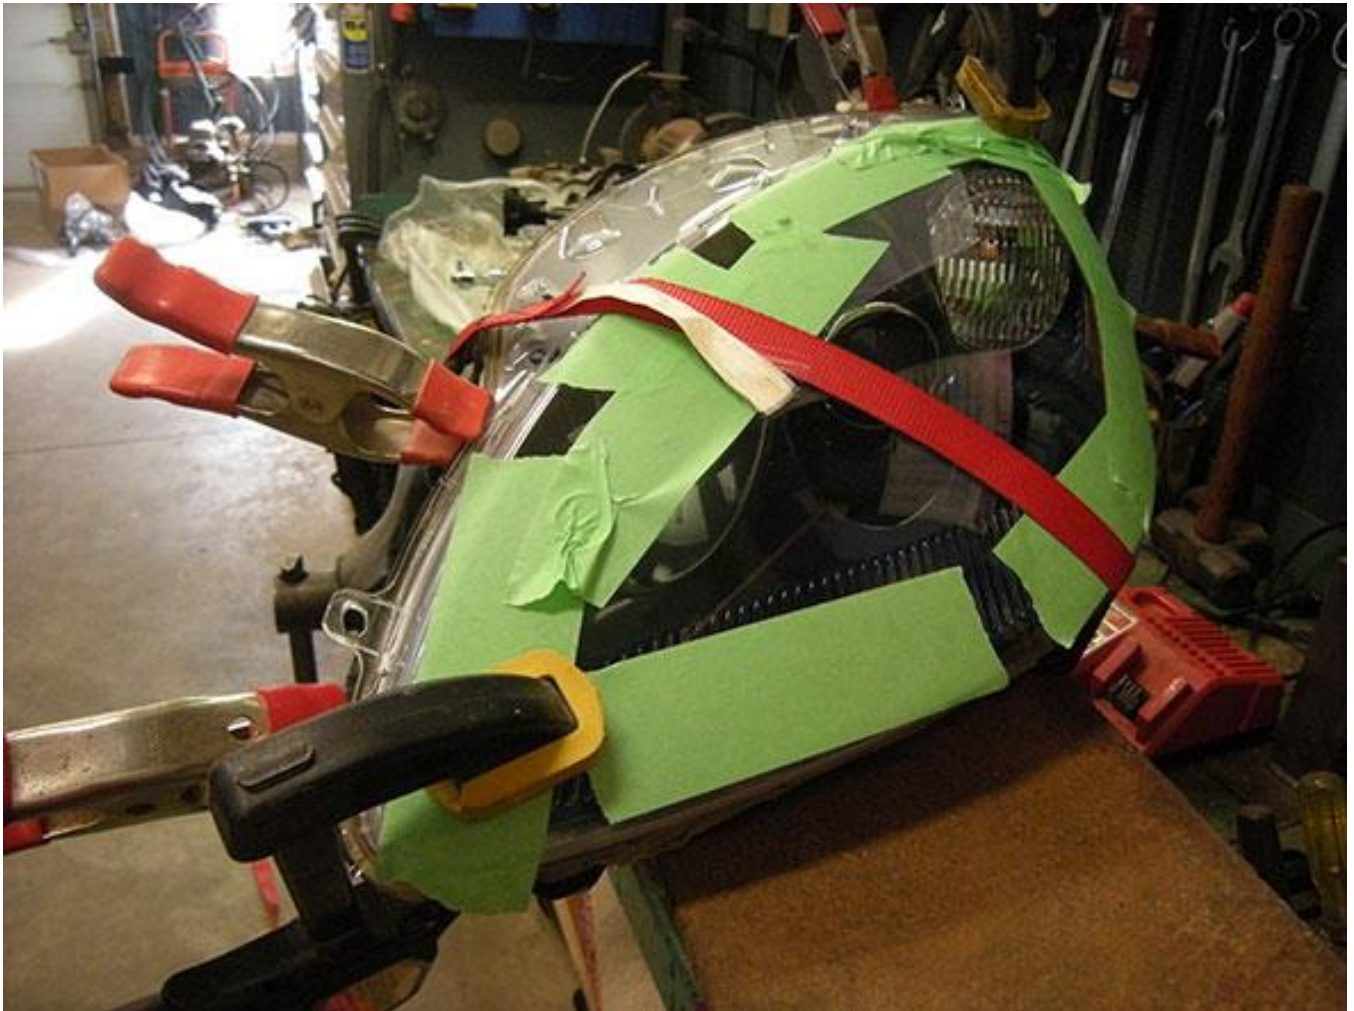
The smooth irregular shape of the lens required presented a clamping challenge! After 24 hours, the glue was set and the assembly was ready to be re-installed in the car.

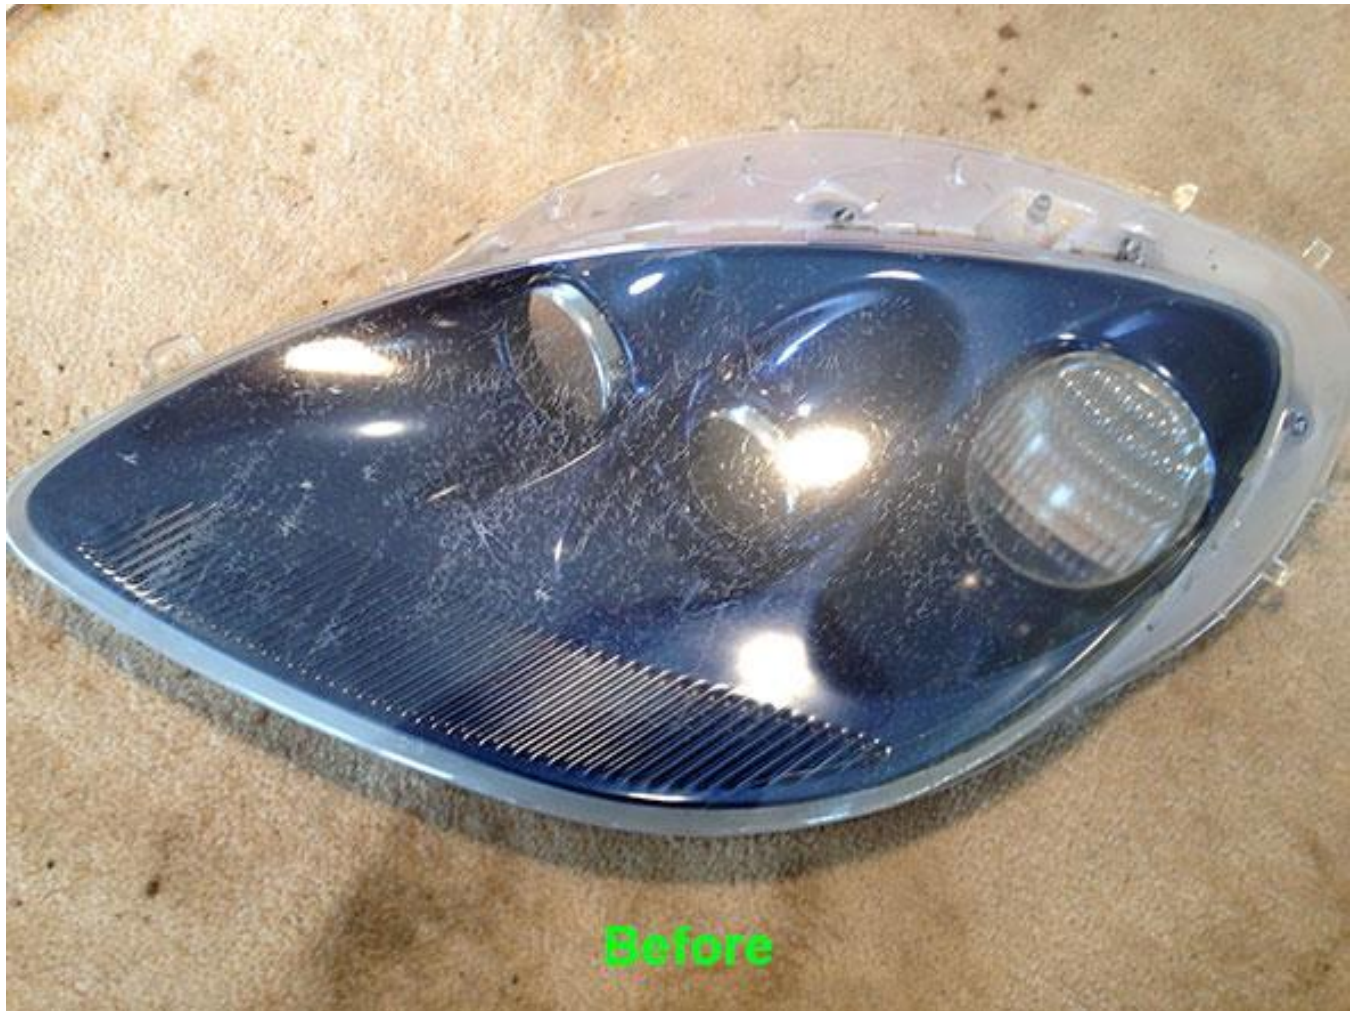
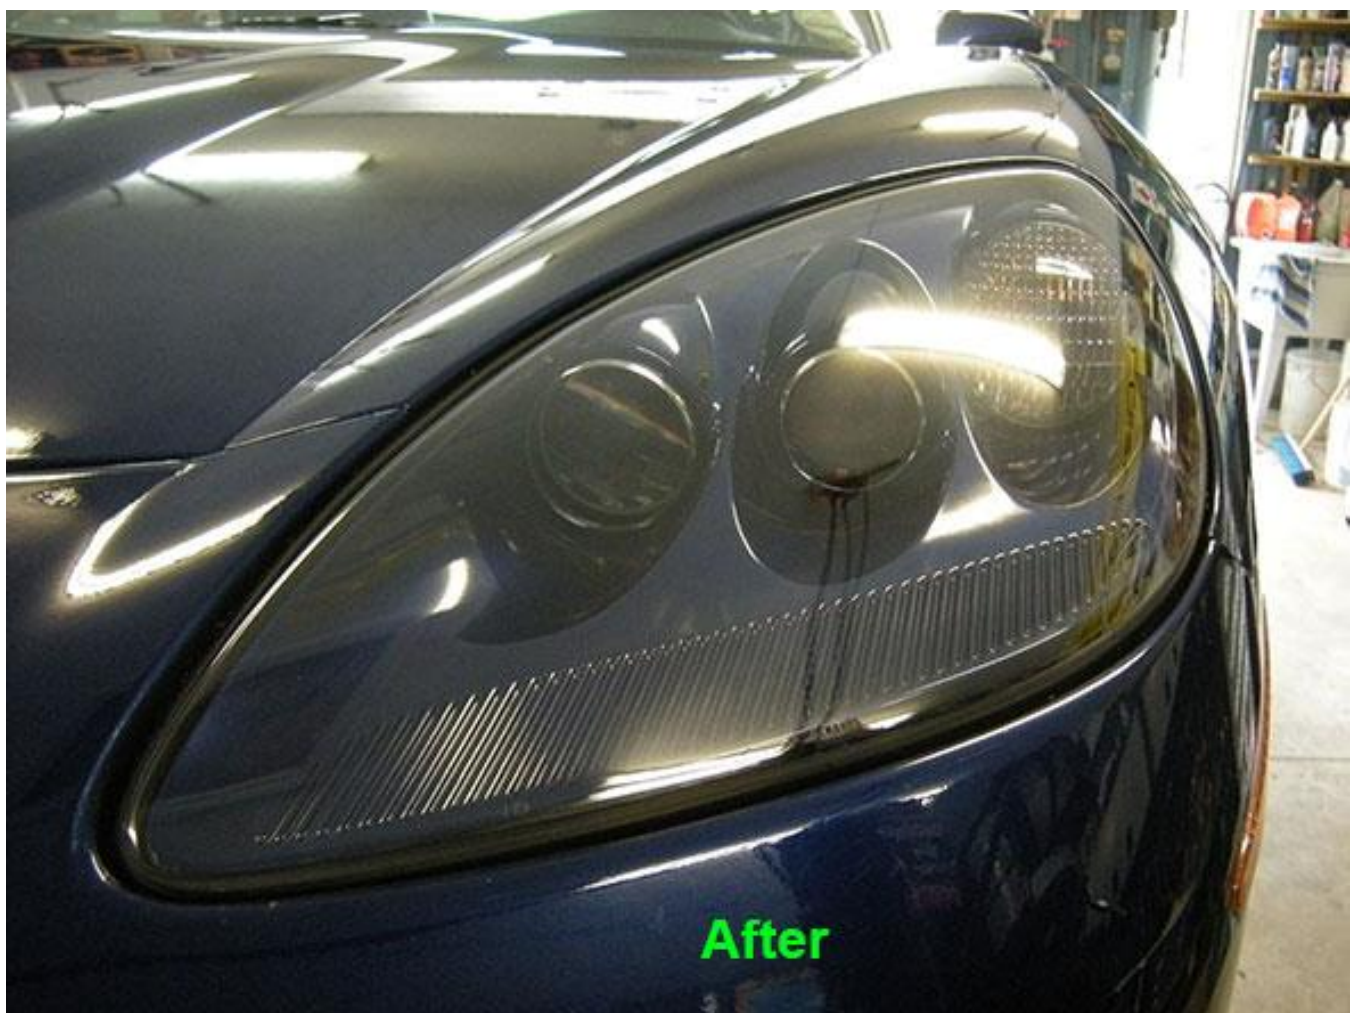
The rest of the car was put back together in the reverse order of how it was taken apart.

All parts were purchased through eBay. Each lens cost \$155 USD. The rubber body gasket that surrounds each light was replaced with new ones. They cost \$49.98 USD each. It was recommended that the wiring harness for each headlight be replaced due to known issues with original harnesses. Each harness cost \$36.95 USD.
