Introduction to the Trailing Arm Replacement Procedure

Step 1: Preparing the rear end of the car for the trailing arm replacement.

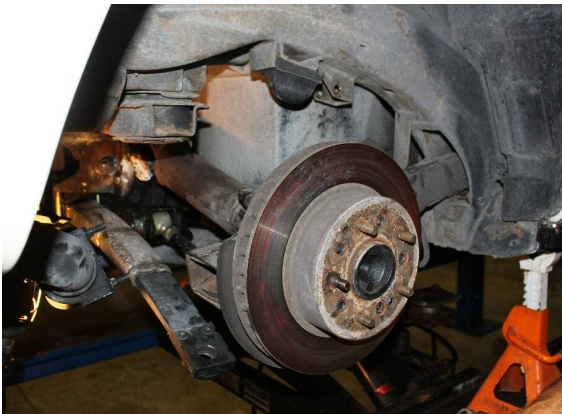
Original passenger side trailing arm, almost ready to remove

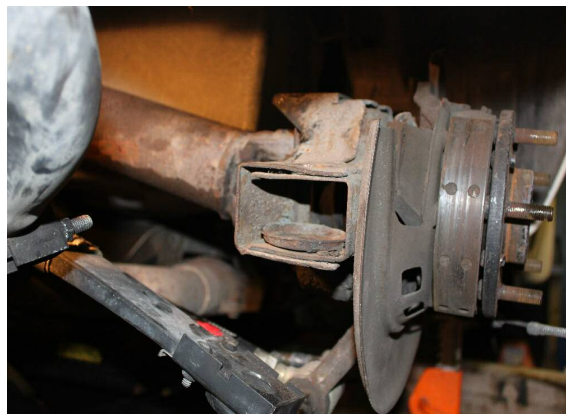
Close up of the passenger side trailing arm box shape. Note the apparent deformation of the two halves of the box shape

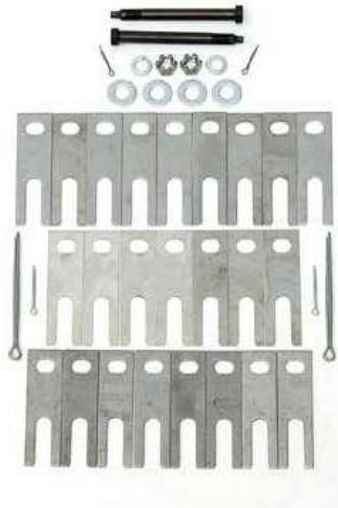
- Apply a generous amount of penetrating fluid to the trailing arm pivot bolt, shims, castle nut and cotter pin and then wait for a few minutes.
- Remove the cotter pin through the castle nut, or cut if necessary.
- Remove the large cotter pin that passes through the holes in the shims. Note the illustration below which shows the shims, the two sizes of cotter pins and other associated hardware used in this procedure.

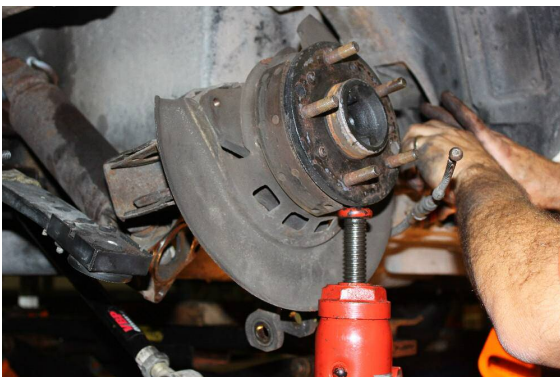
Use of bottle jack to support trailing arm and allow clear access to shims

- Support the trailing arm as it is heavy and it will fall if not supported when the pivot bolt is cut. We used a bottle jack as shown in the photograph below.

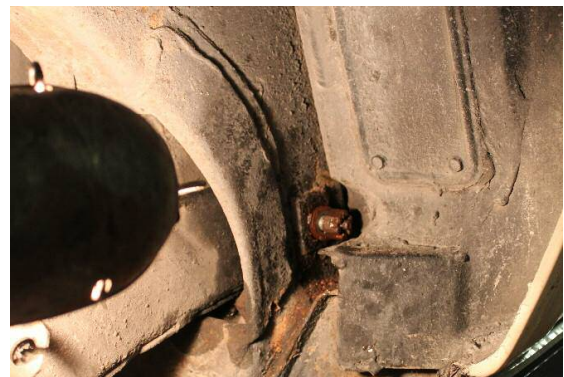
Loosened rusted trailing arm castle nut minus the cotter pin

- Gently work the castle nut back and forth to get it moving. If possible, remove the nut using a wrench on the bolt head and a wrench or ratchet on the castle nut. Worst case scenario, cut off the castle nut with a reciprocating saw.

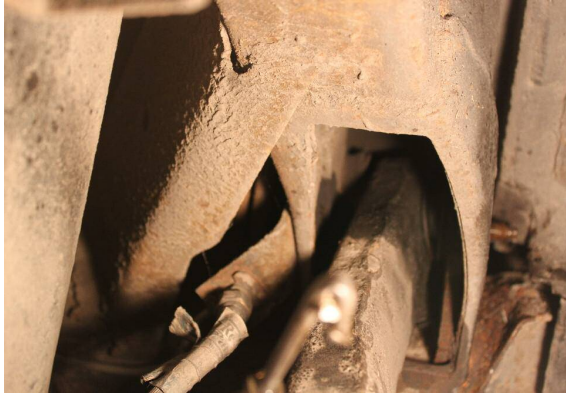
Close up of the trailing arm with the castle nut removed and the pivot bolt still in place.

Note the vertical alignment skew of the trailing arm even with the shims still there.

- Next, either cut the pivot bolt or using an impact chisel, get the bolt to move toward the inboard side of the car. If it does move, you will be able to wiggle it back and forth until it is free. In some cases the pivot bolt may need to be cut with a reciprocating saw.

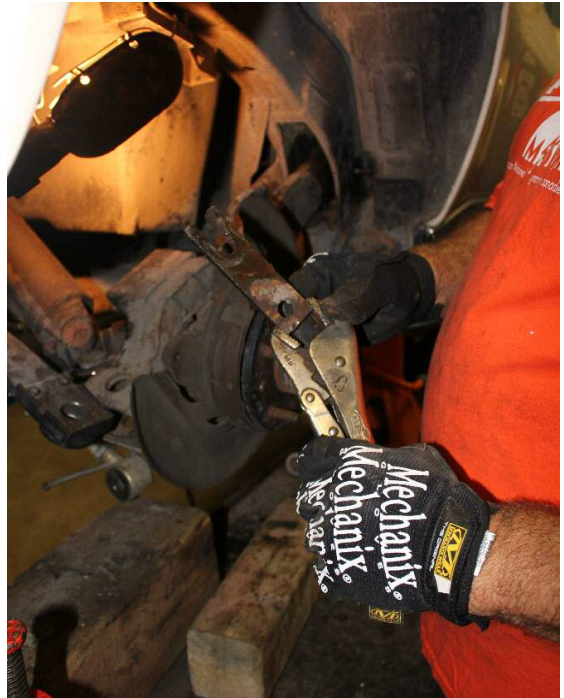
Close up of the first shims to be removed.

- Using various “persuasive” hand-held tools and lots of penetrating fluid, loosen and remove the inboard and outboard shims, noting the thickness and location of each shim. These will be replaced by identical thickness and number of shims on each side of the trailing arm when the new trailing arm is installed.

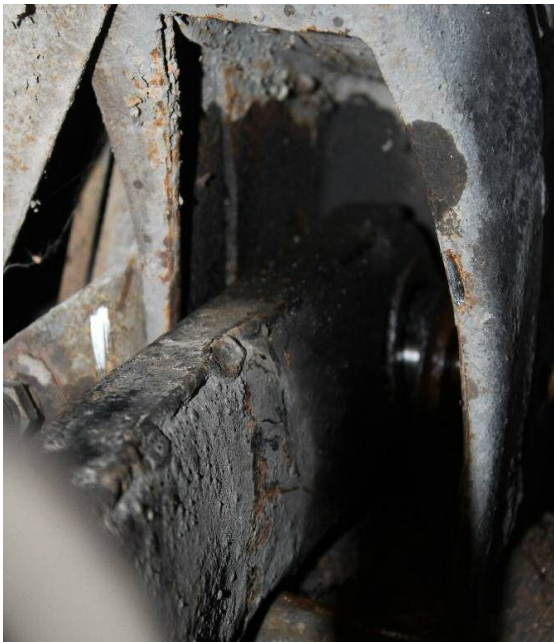
Close up of the trailing arm with the shims removed.

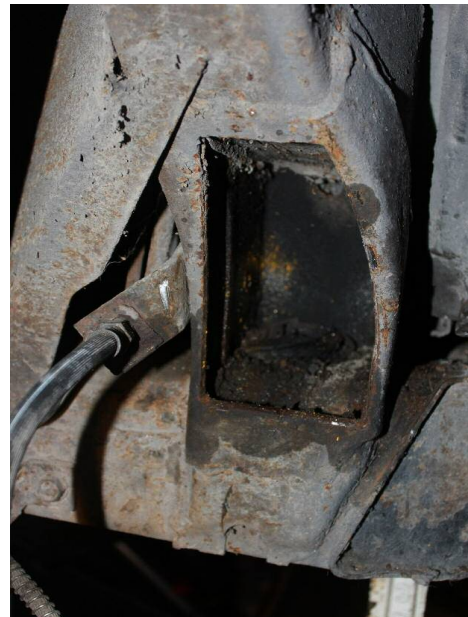
Close up of the trailing arm mount with the trailing arm removed. Look closely to see bushing bits lying in the frame.

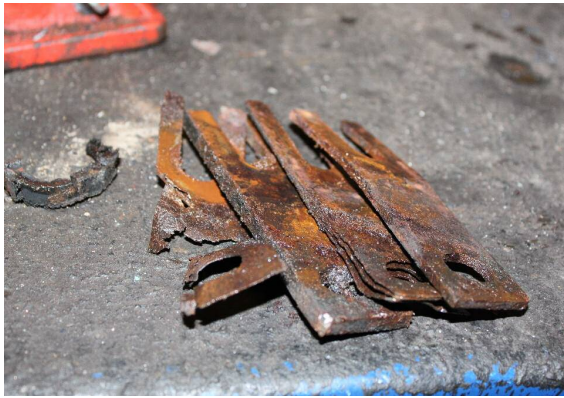
Passenger side inboard shims and bushing remnants

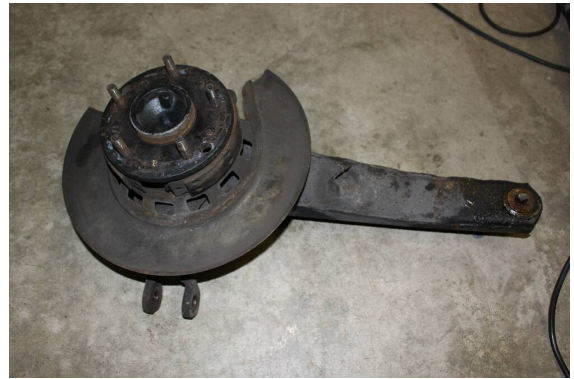
Passenger side trailing arm removed

- Carefully remove the trailing arm and set aside for the moment.

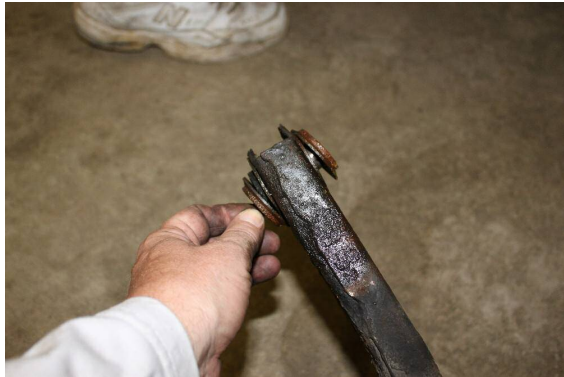
Note the "little bit" of play in the passenger's side pivot bolt and bushing.

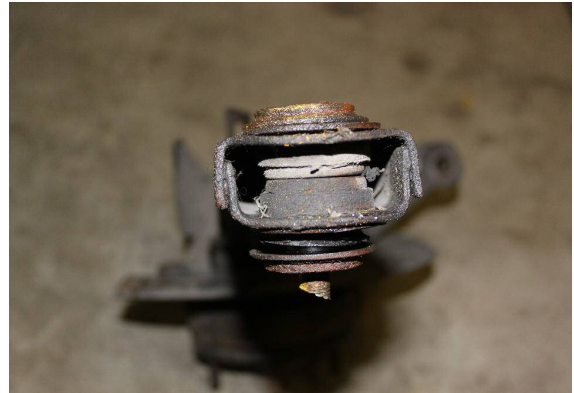
Close up of the passenger side bushings, notice one side bushing has deteriorated and is missing.

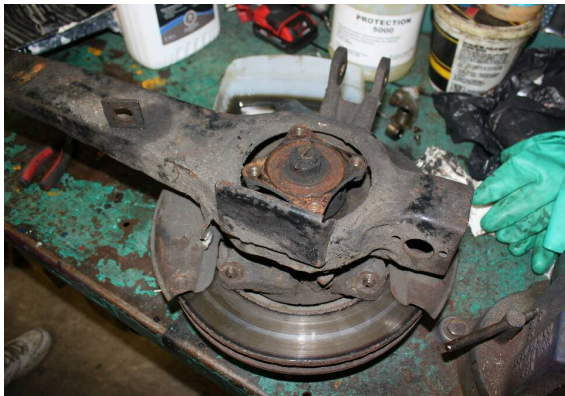
Close up of the old trailing arm showing the spindle nut and flange.

- As the new trailing arm did not come with a replacement spindle flange and nut, the old spindle flange and nut must be removed and reused.
- With the trailing arm on a bench, use a large impact gun to remove the old spindle nut and flange.
- Install the old spindle flange and nut on the new trailing arm using 100 ft-lbs of torque.

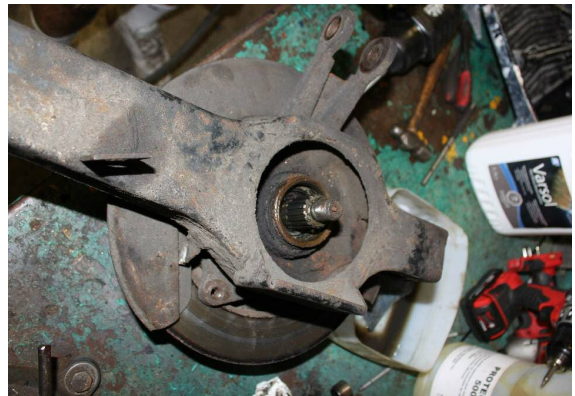
Close up of the old trailing arm with the spindle nut and flange removed.

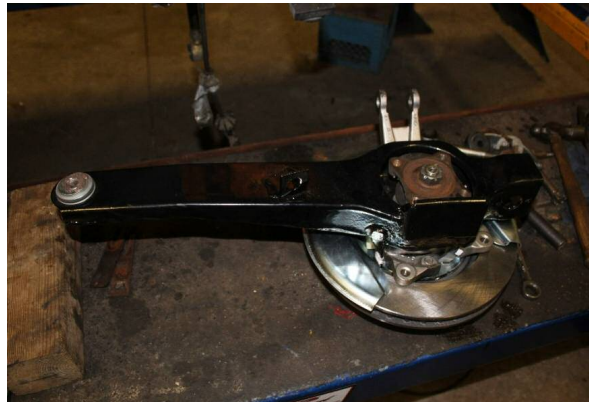
New trailing arm with the old spindle nut and flange installed and tightened to 100 ft-lbs.

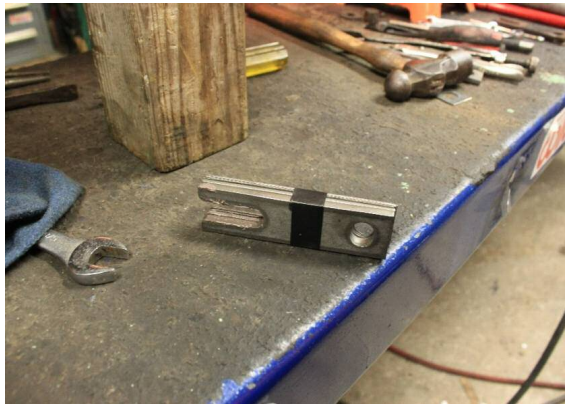
New shims taped together for ease of installation.

- The installation of the new trailing arms is just a reversal of the process described to this point, but it should be much easier of course.
- Ron has a good policy whenever he installs new parts, or reinstalls used but still serviceable parts. In the past when Ron has worked on my car he has used anti-seize compound on parts that assemble together. This enabled us to disassemble much of the suspension components on this repair with little or no trouble.
- Prior to installing the new stainless steel shims we taped the appropriate shims together. This made the handling of multiple shims in a confined space much easier.

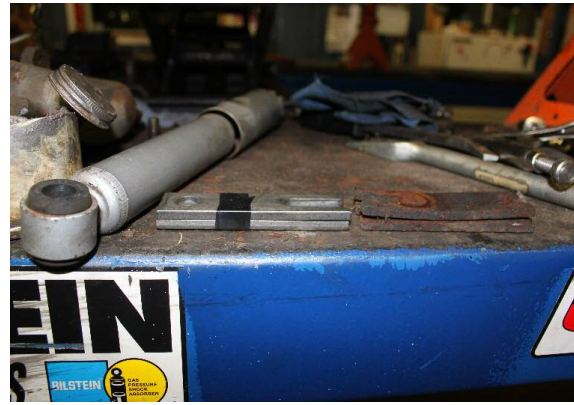
Old shims on the right, new matching thickness shims on the left.

- The shims are then placed in the same order as the old ones came out. Then a large cotter pin is passed through the trailing arm mount and holes pre-drilled in the shims to hold them in place.

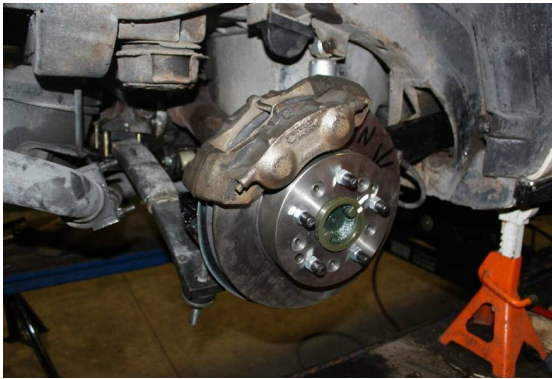
New passenger side trailing arm in place.
Elapsed time 3.5 hours.

Total time for both sides was 7.0 hours before bleeding the brakes and doing the final check and test drive.

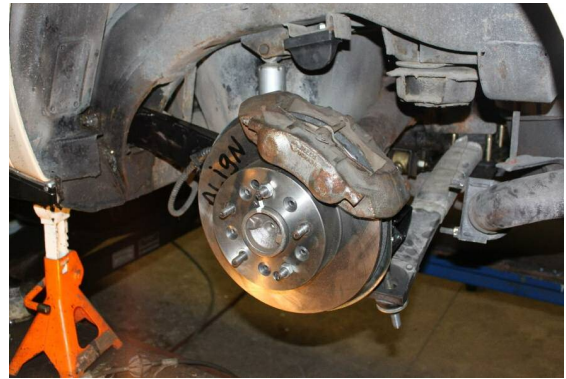
New drivers side trailing arm in place.
Elapsed time 2.5 hours.
